# Technical Memorandum Geophysics Prove-Out Study Task 2.2

## *West Valley Demonstration Project and Western New York Nuclear Service Center*

**April 2017**

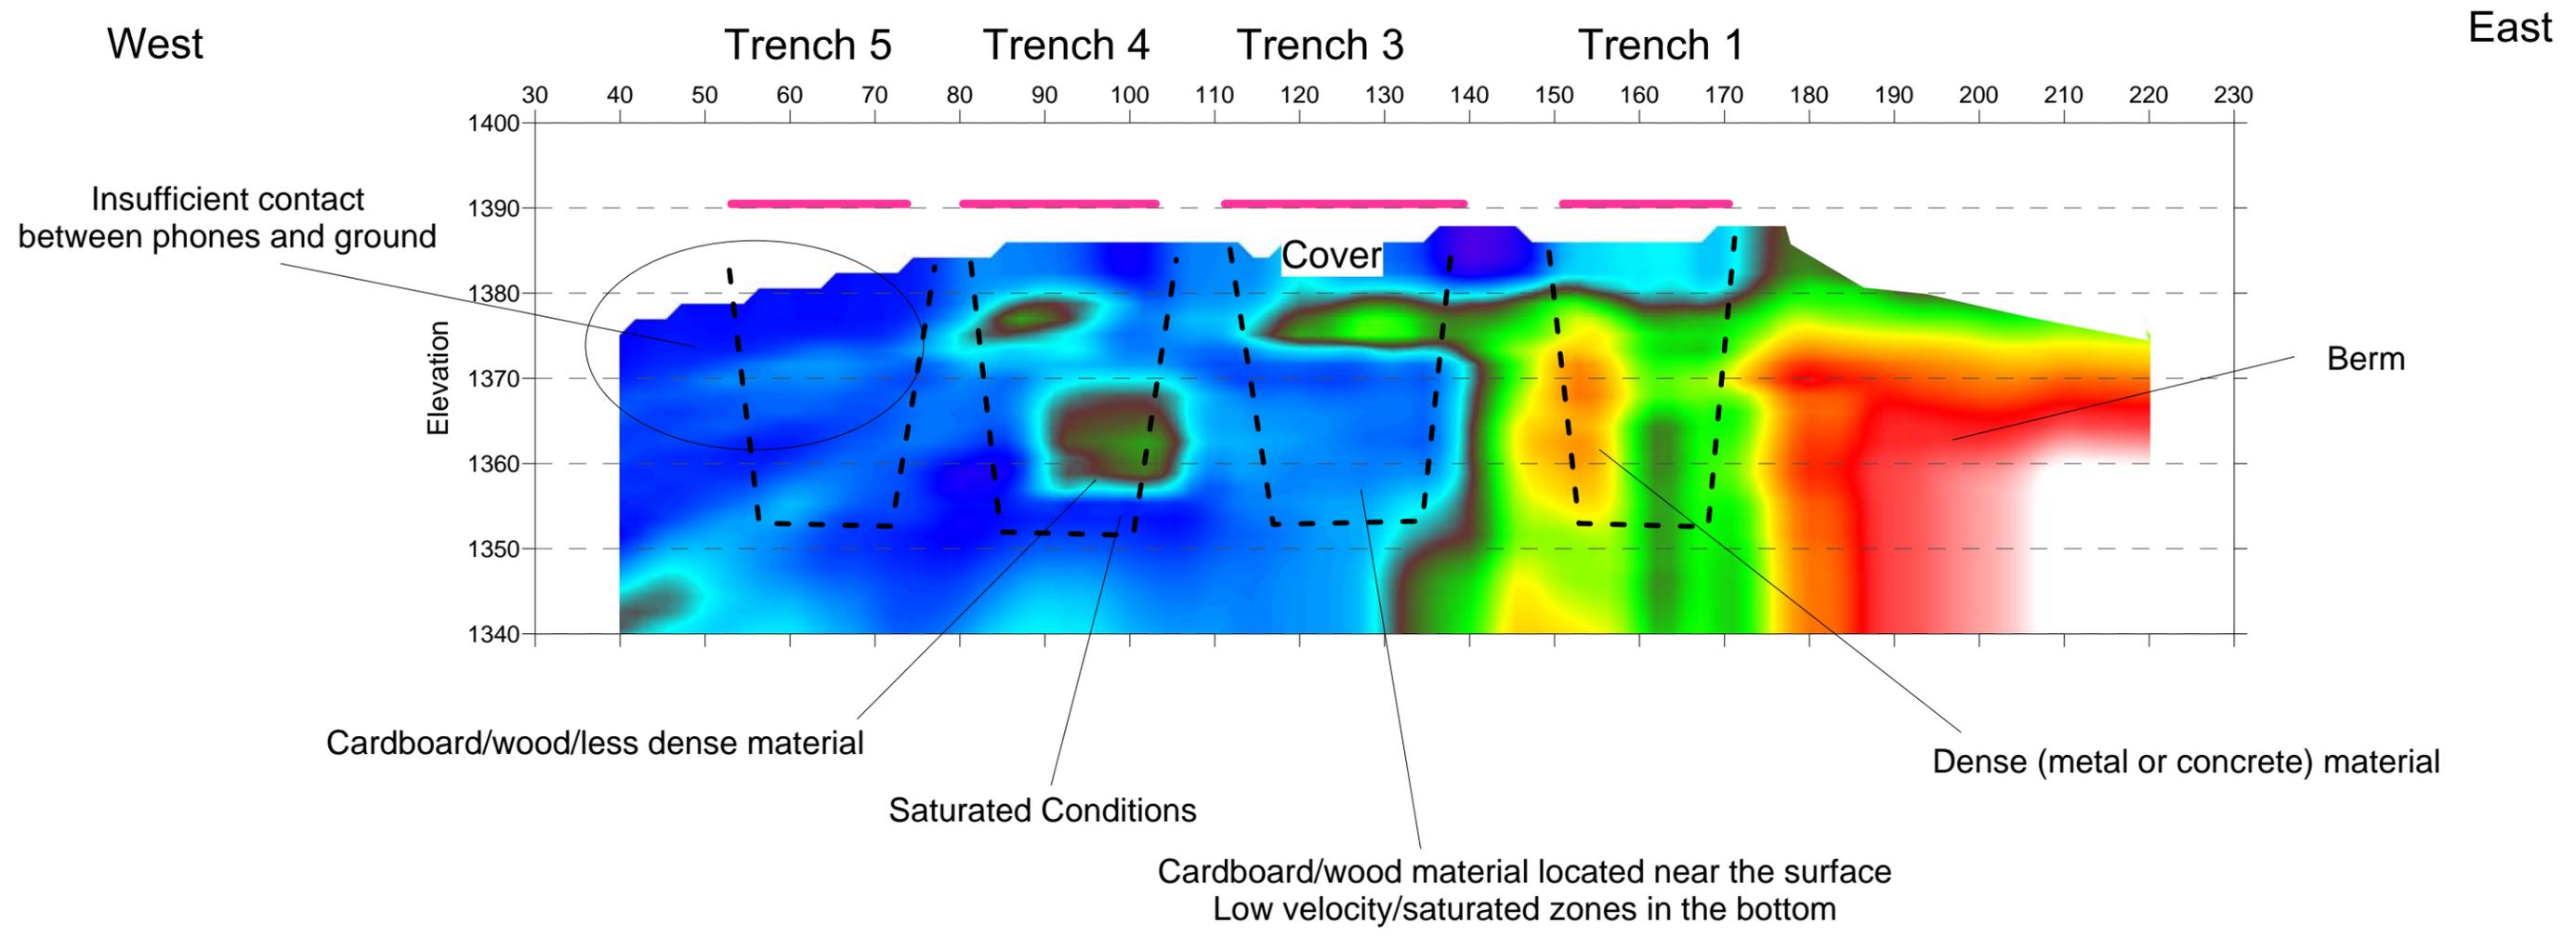
<b>MASW Profile A: Landstreamer Fundamental Mode</b>	
West Valley Demonstration Project Western New York Nuclear Service Center	
Enviro Compliance Solutions, Inc. (ECS) 4795 Blue Mountain Drive Yorba Linda, California	
October 2016	Figure 3

— Location of Trenches Based on Aerial Photographs

- - - Reported Location of Trenches

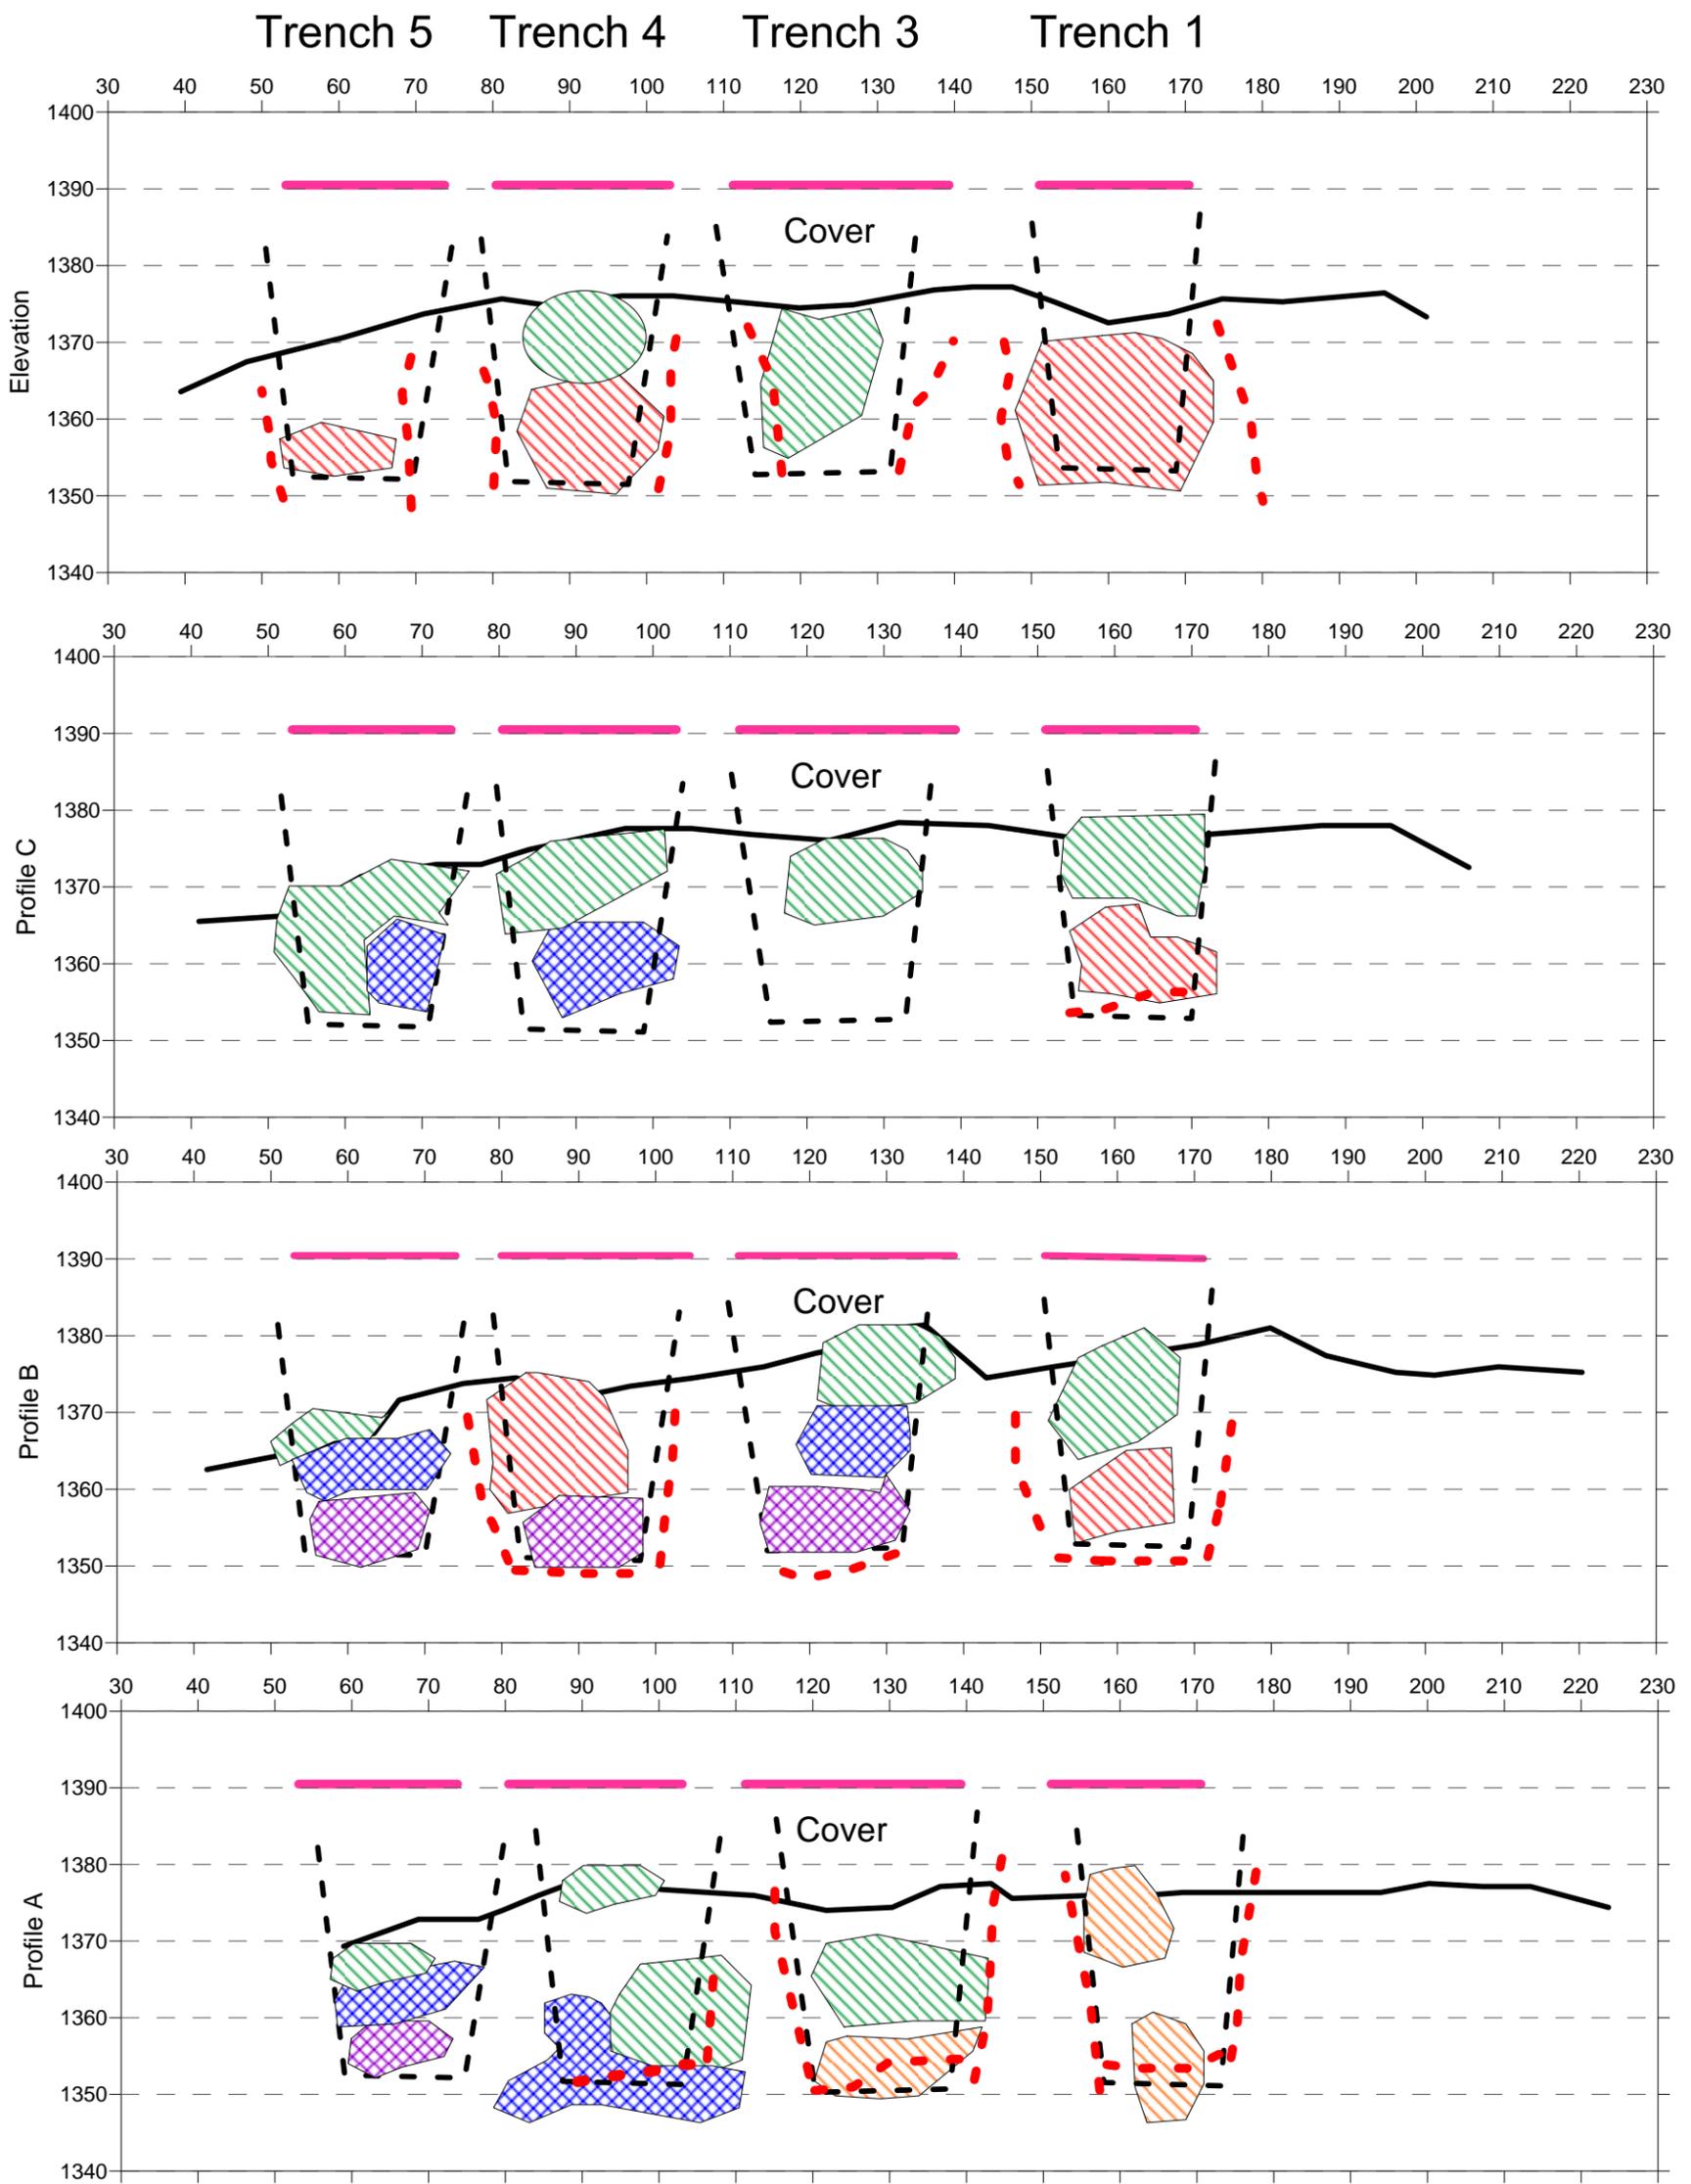
<b>Cross-Sections of Trenches</b>	
West Valley Demonstration Project Western New York Nuclear Service Center	
Enviro Compliance Solutions, Inc. (ECS) 4795 Blue Mountain Drive Yorba Linda, California	
October 2016	Figure 18

- Dense Material/Metal/Concrete Dry Conditions
- Dense Material/Metal/Concrete Saturated Conditions
- Cardboard/Wood Dry
- Cardboard/Wood Saturated Conditions
- Interpreted Bottom of Cover Material
- Location of Trenches (Aerial Photographs)
- Reported Location of Trenches
- Interpreted Sides/Bottom of Trench

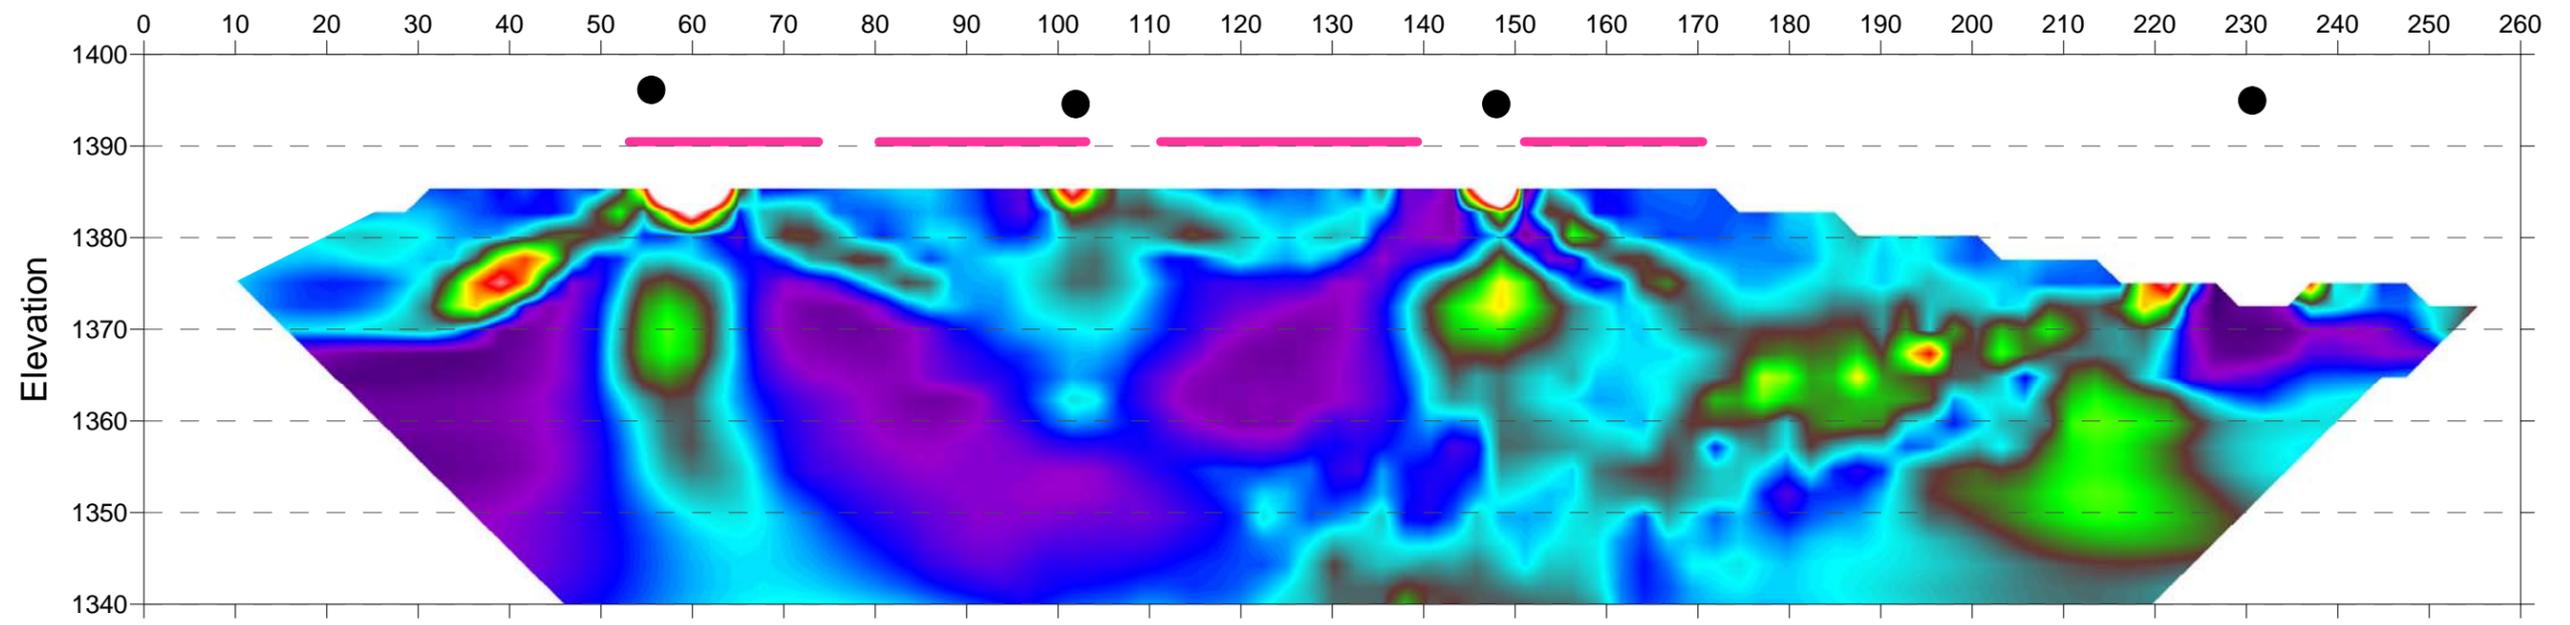
<b>ERI Profile A</b>	
West Valley Demonstration Project Western New York Nuclear Service Center	
Enviro Compliance Solutions, Inc. (ECS) 4795 Blue Mountain Drive Yorba Linda, California	
October 2016	Figure 19

● Skipped Electrode

Ohm-Meters

The ERI method effectiveness proved to be impacted by the metal in the trenches and would not be recommended for further consideration to meet the geophysical objectives.

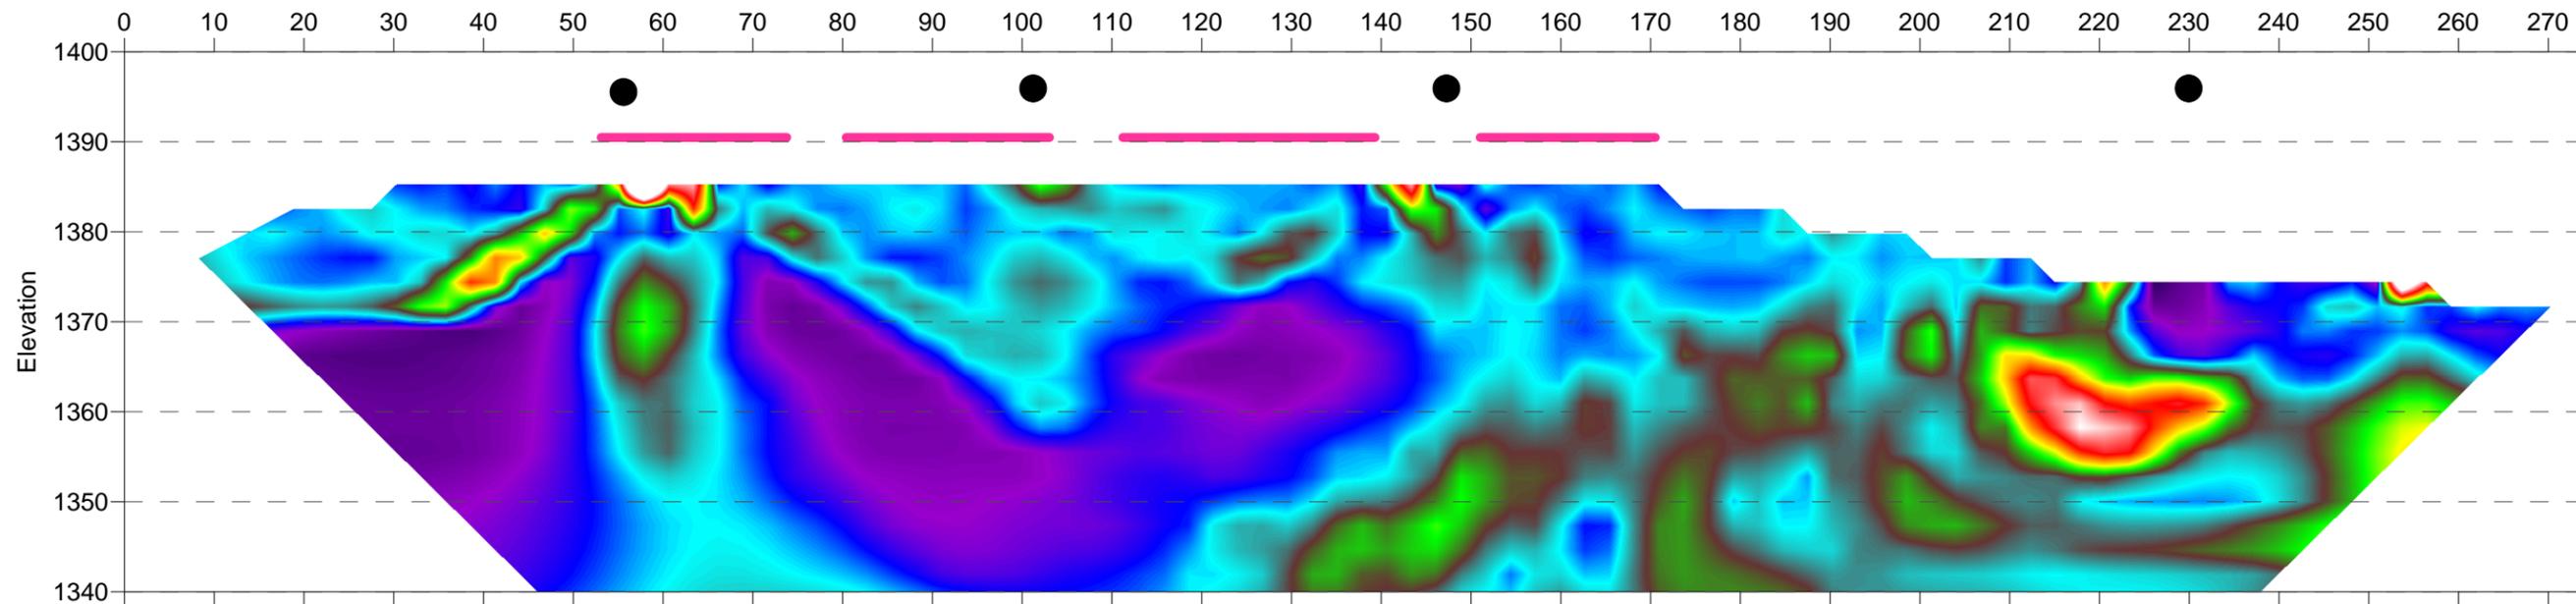
<b>ERI Profile B</b>	
West Valley Demonstration Project Western New York Nuclear Service Center	
Enviro Compliance Solutions, Inc. (ECS) 4795 Blue Mountain Drive Yorba Linda, California	
October 2016	Figure 20

● Skipped Electrode

Ohm-Meters

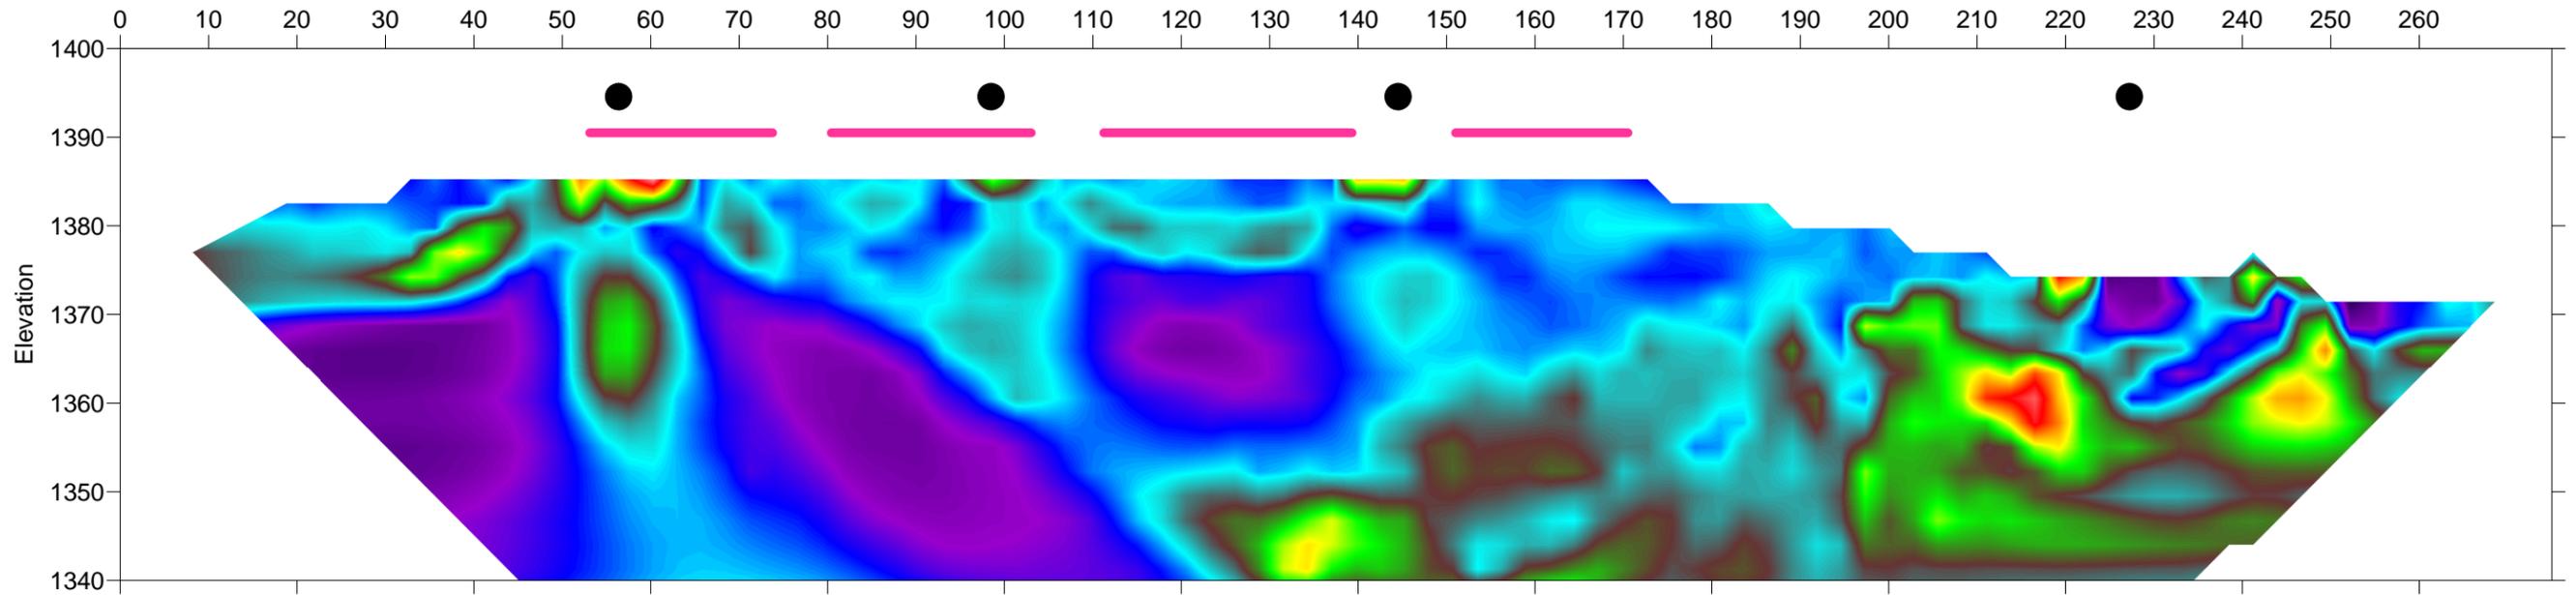
<b>ERI Profile C</b>	
West Valley Demonstration Project Western New York Nuclear Service Center	
Enviro Compliance Solutions, Inc. (ECS) 4795 Blue Mountain Drive Yorba Linda, California	
October 2016	Figure 21

● Skipped Electrode

Ohm-Meters

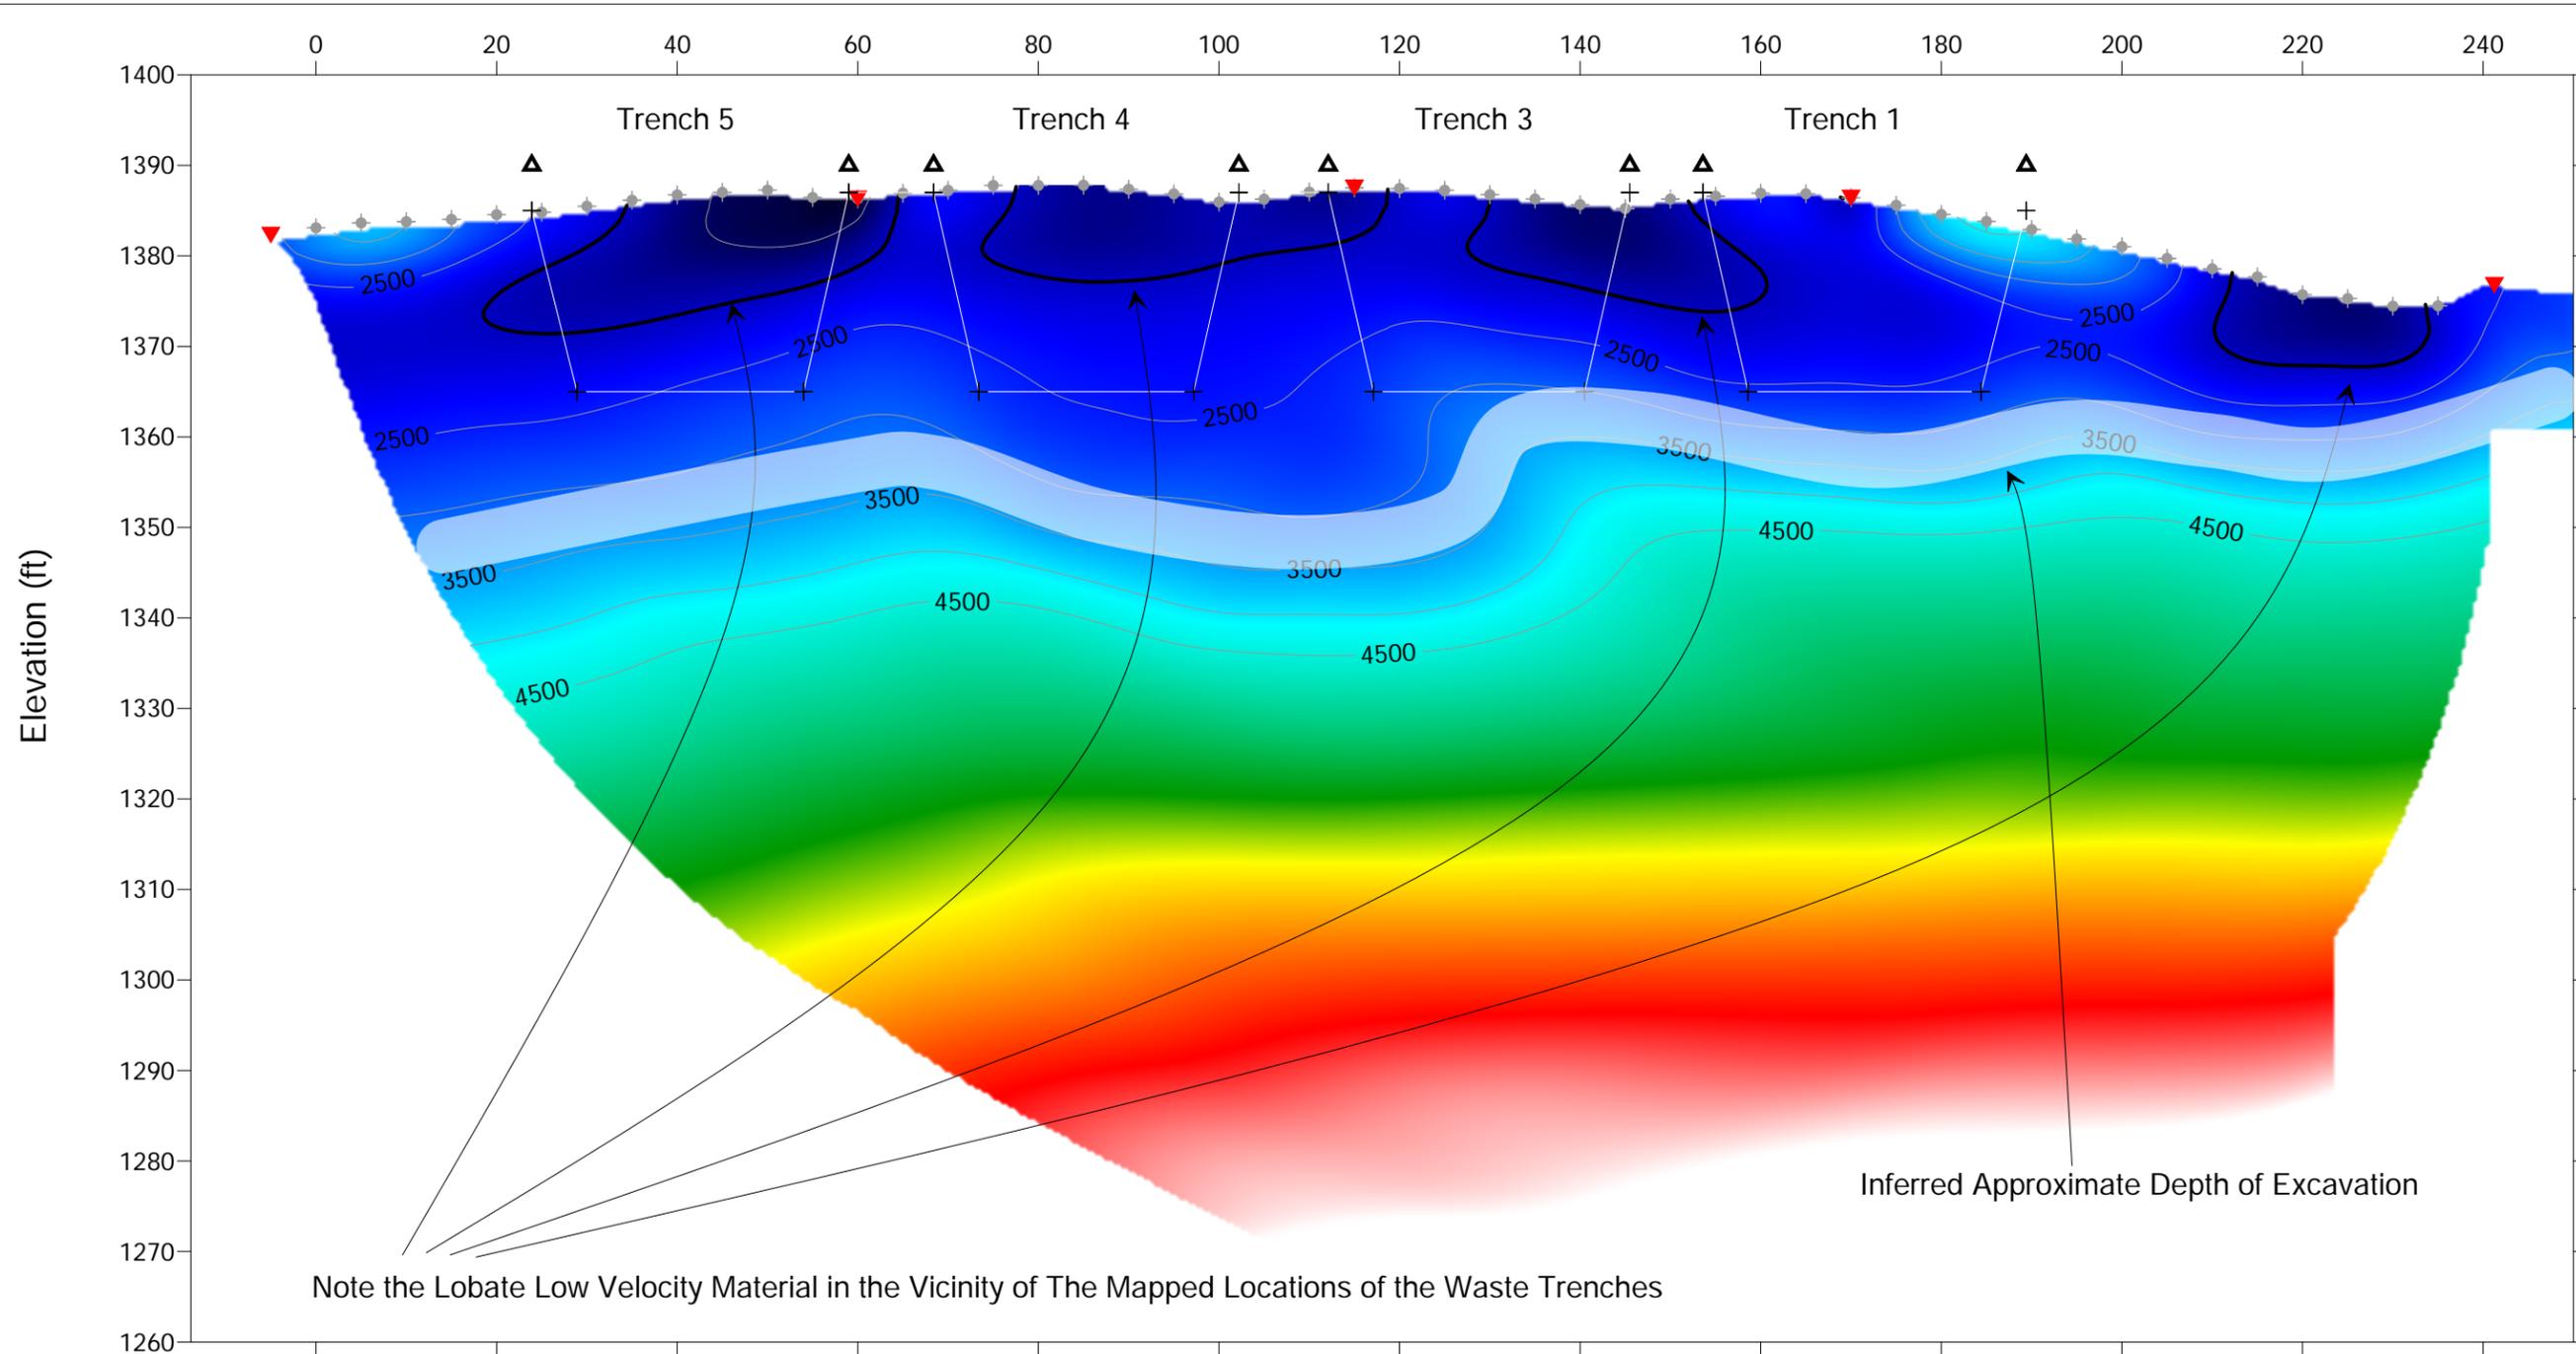
Note the Lobate Low Velocity Material in the Vicinity of The Mapped Locations of the Waste Trenches

Inferred Approximate Depth of Excavation

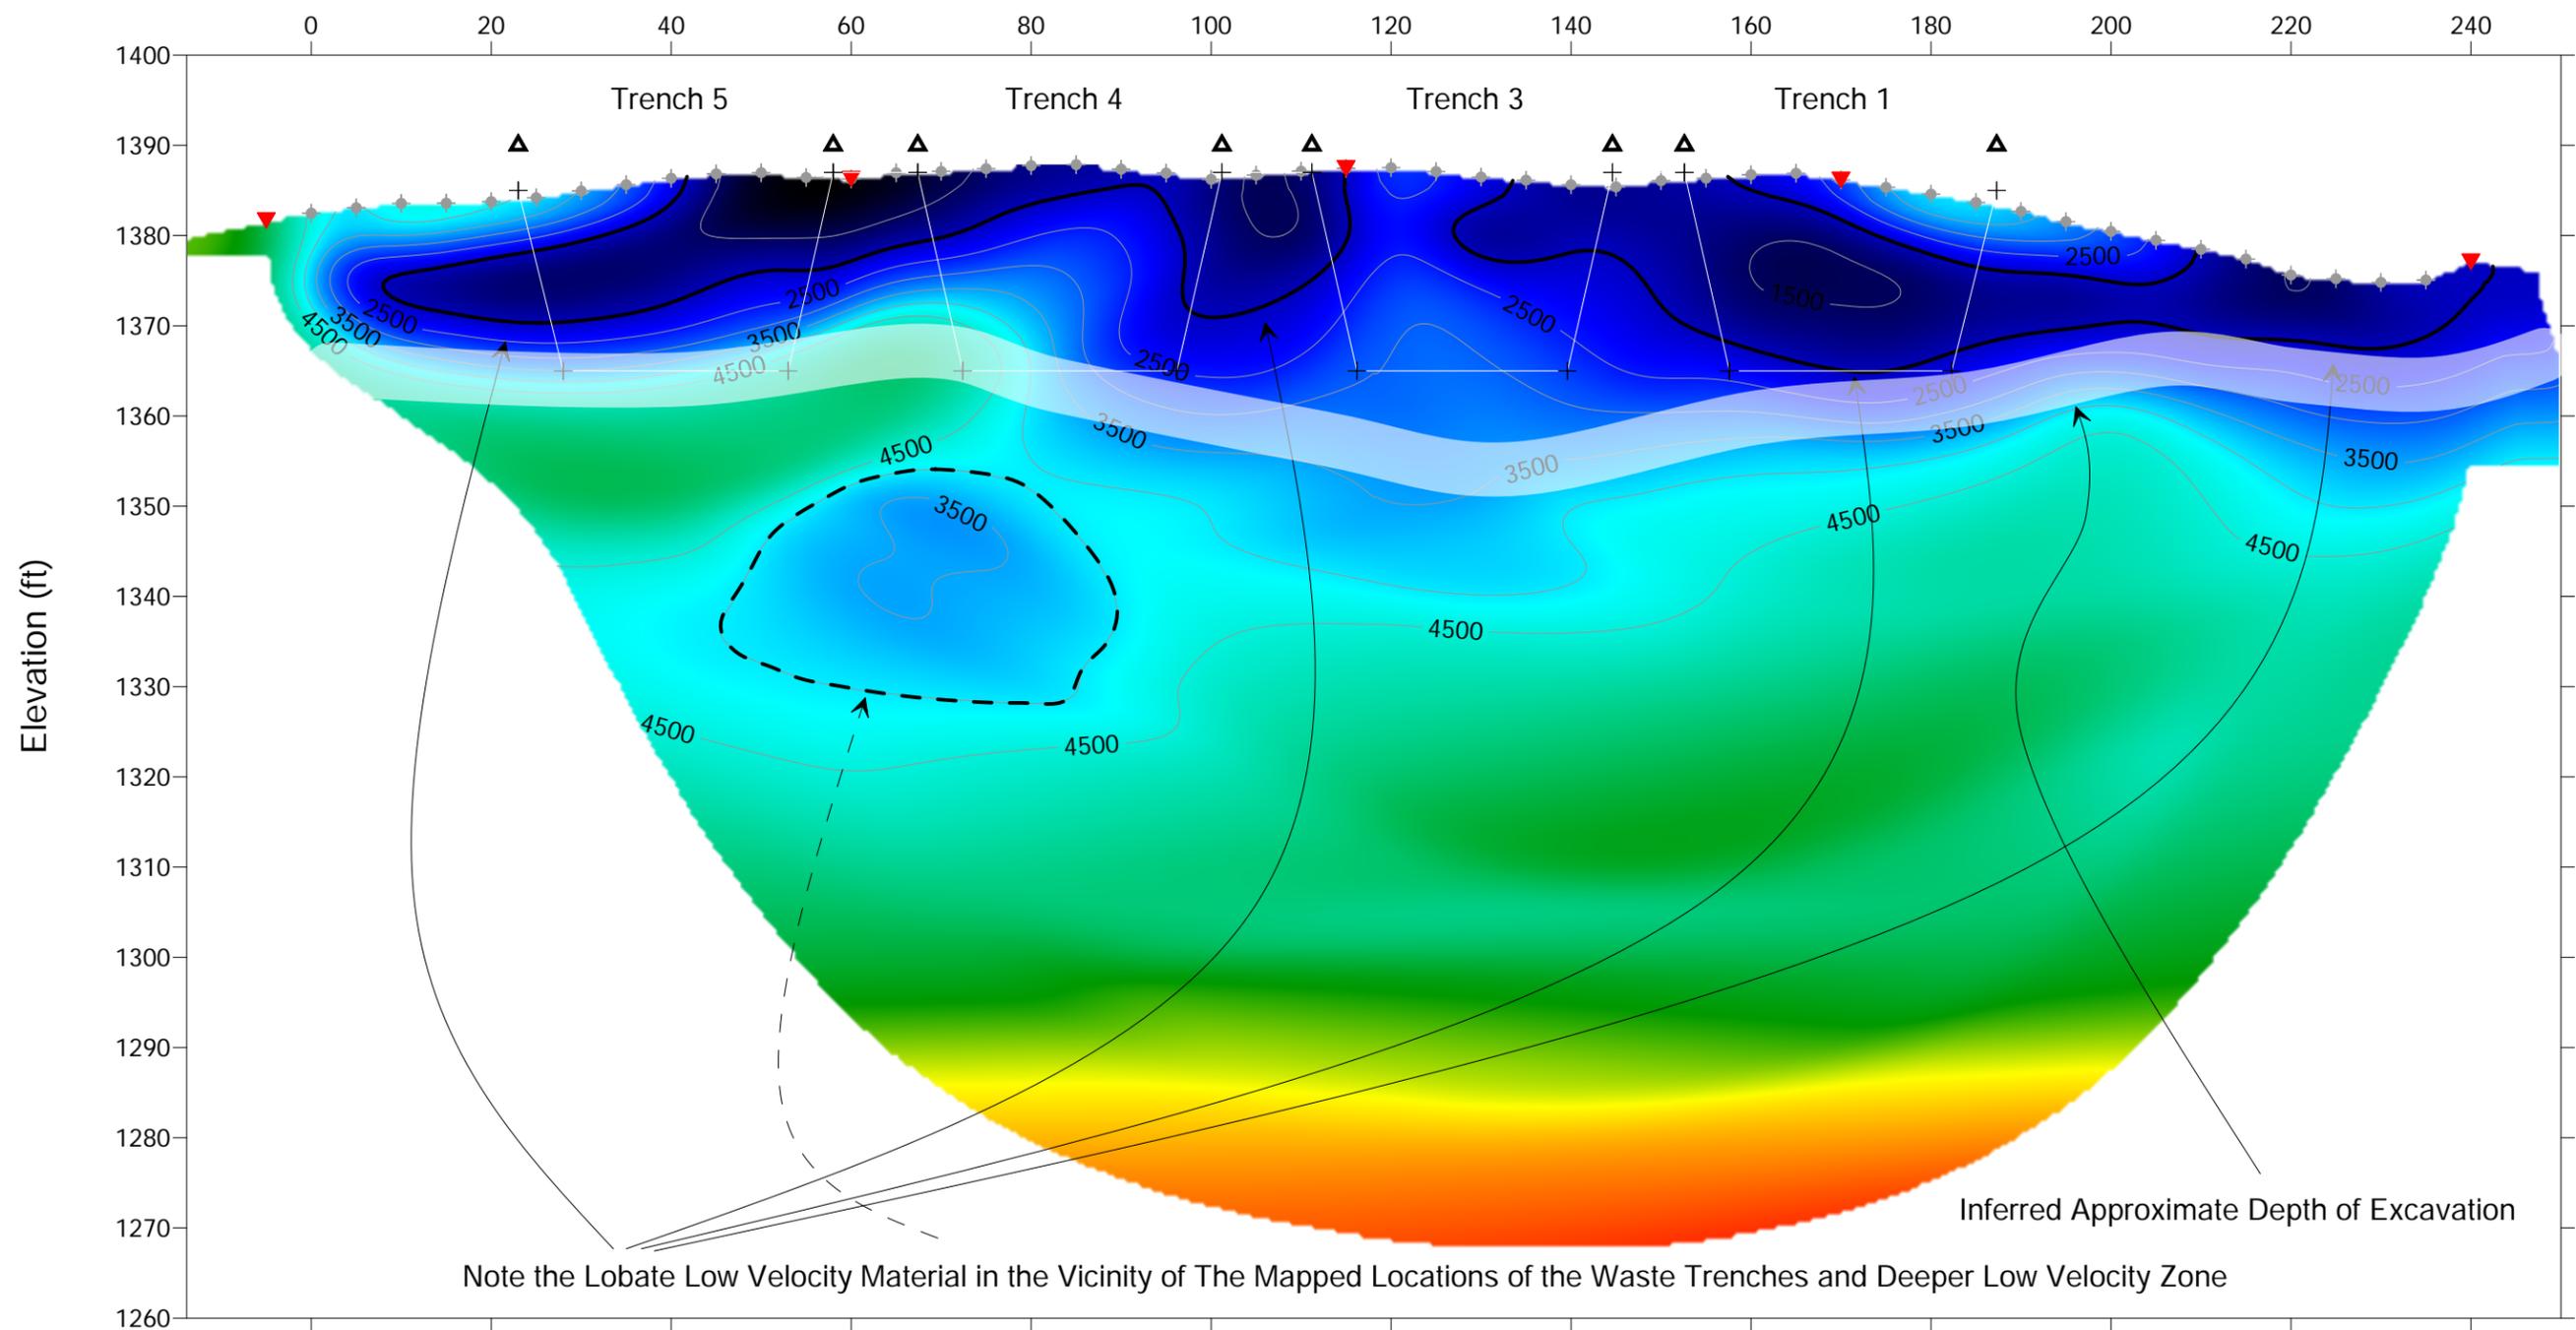
Note the Lobate Low Velocity Material in the Vicinity of The Mapped Locations of the Waste Trenches and Deeper Low Velocity Zone

Inferred Approximate Depth of Excavation

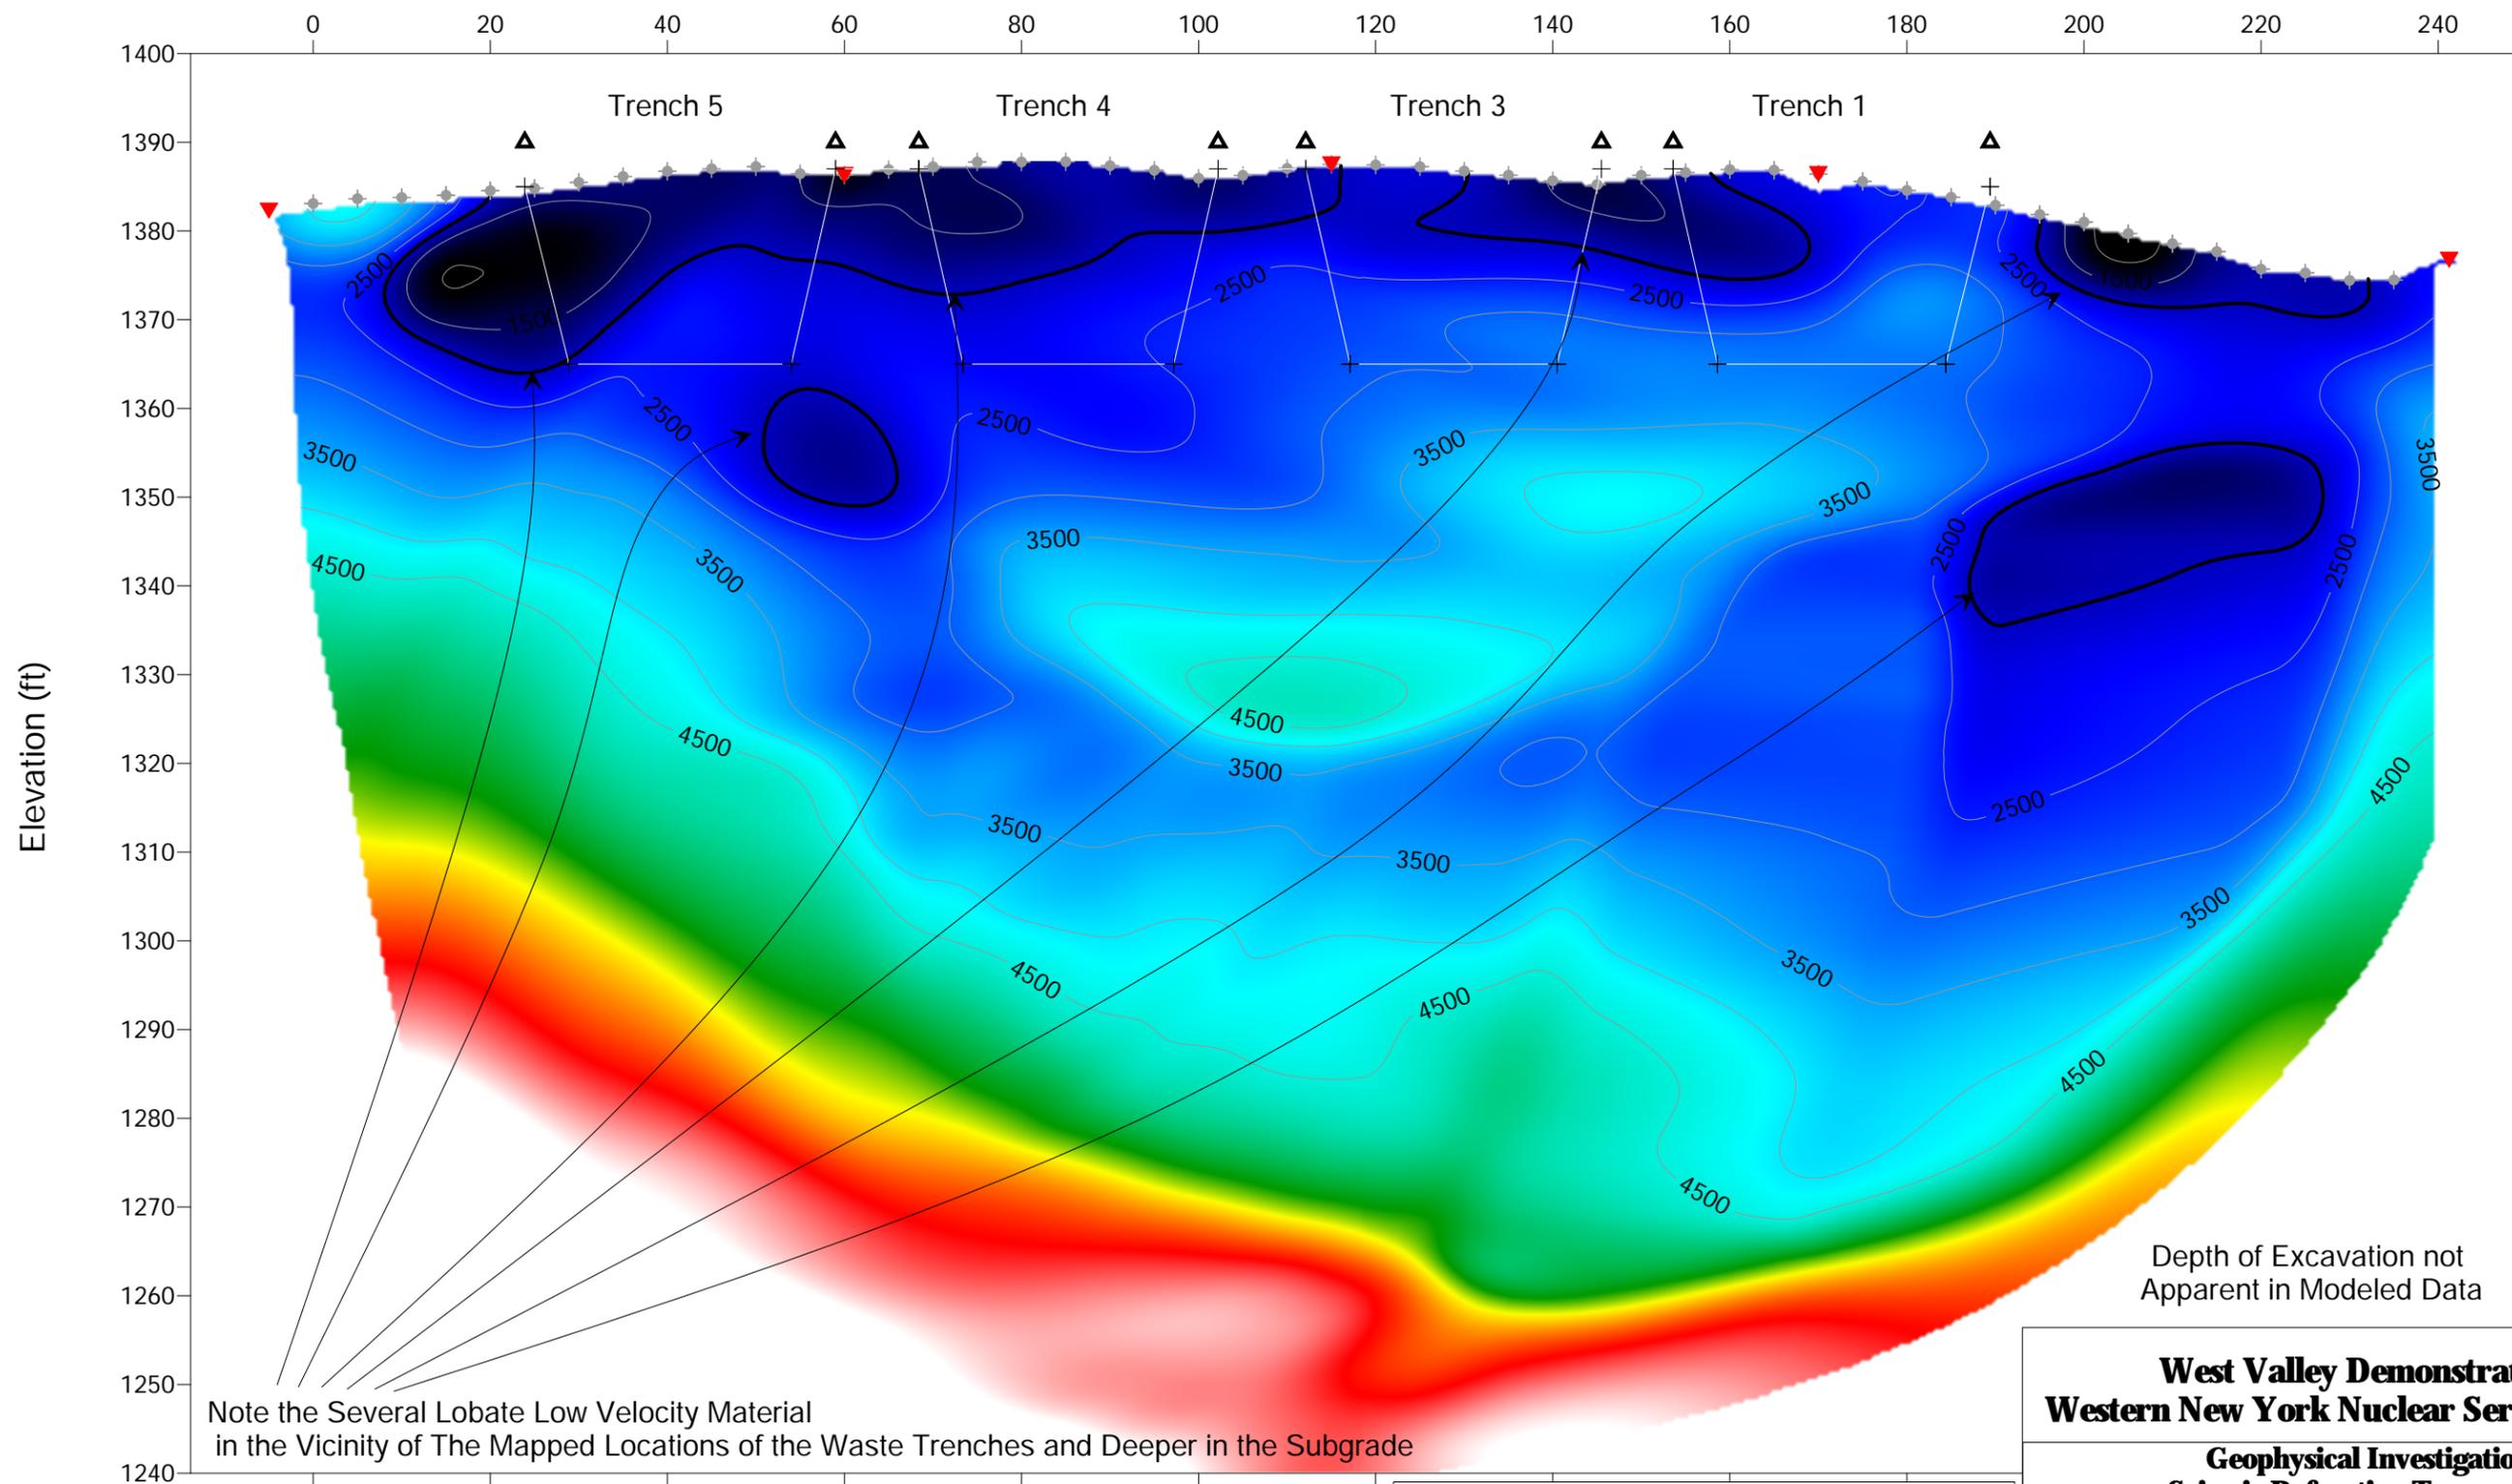
Note the Several Lobate Low Velocity Material in the Vicinity of The Mapped Locations of the Waste Trenches and Deeper in the Subgrade

Depth of Excavation not Apparent in Modeled Data
