# Technical Memorandum Geophysics Prove-Out Study Task 2.2

## *West Valley Demonstration Project and Western New York Nuclear Service Center*

**April 2017**

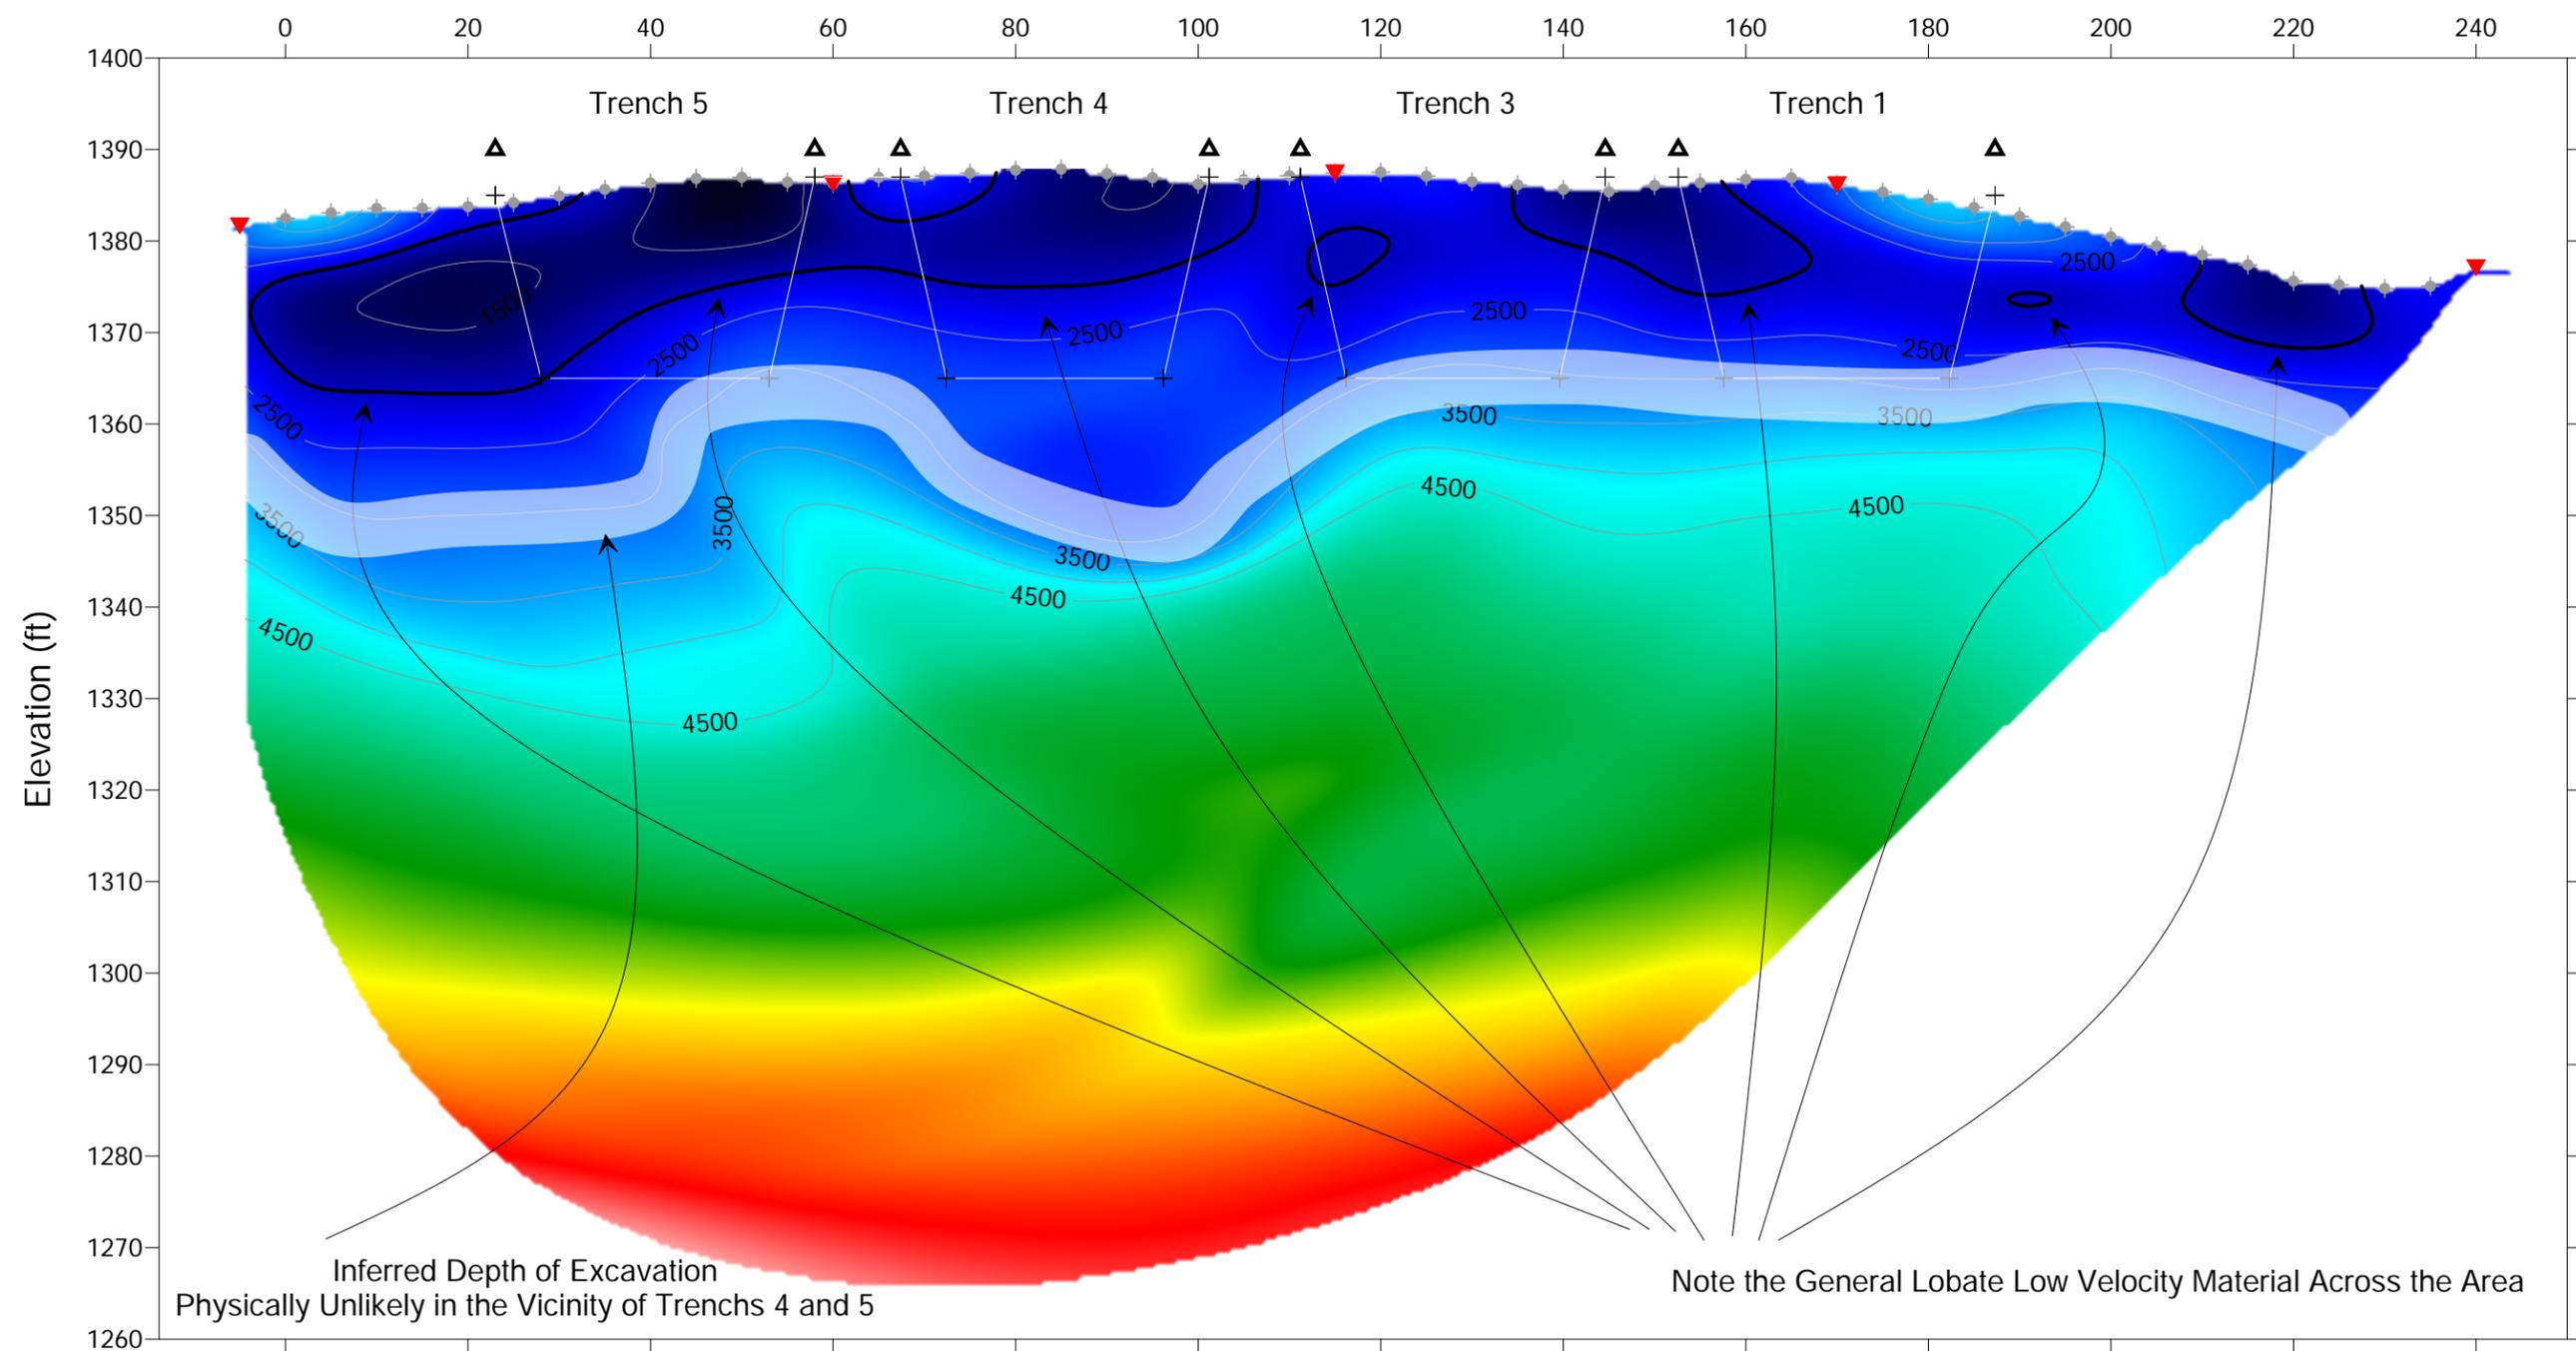
Inferred Depth of Excavation  
Physically Unlikely in the Vicinity of Trenches 4 and 5

Note the General Lobate Low Velocity Material Across the Area

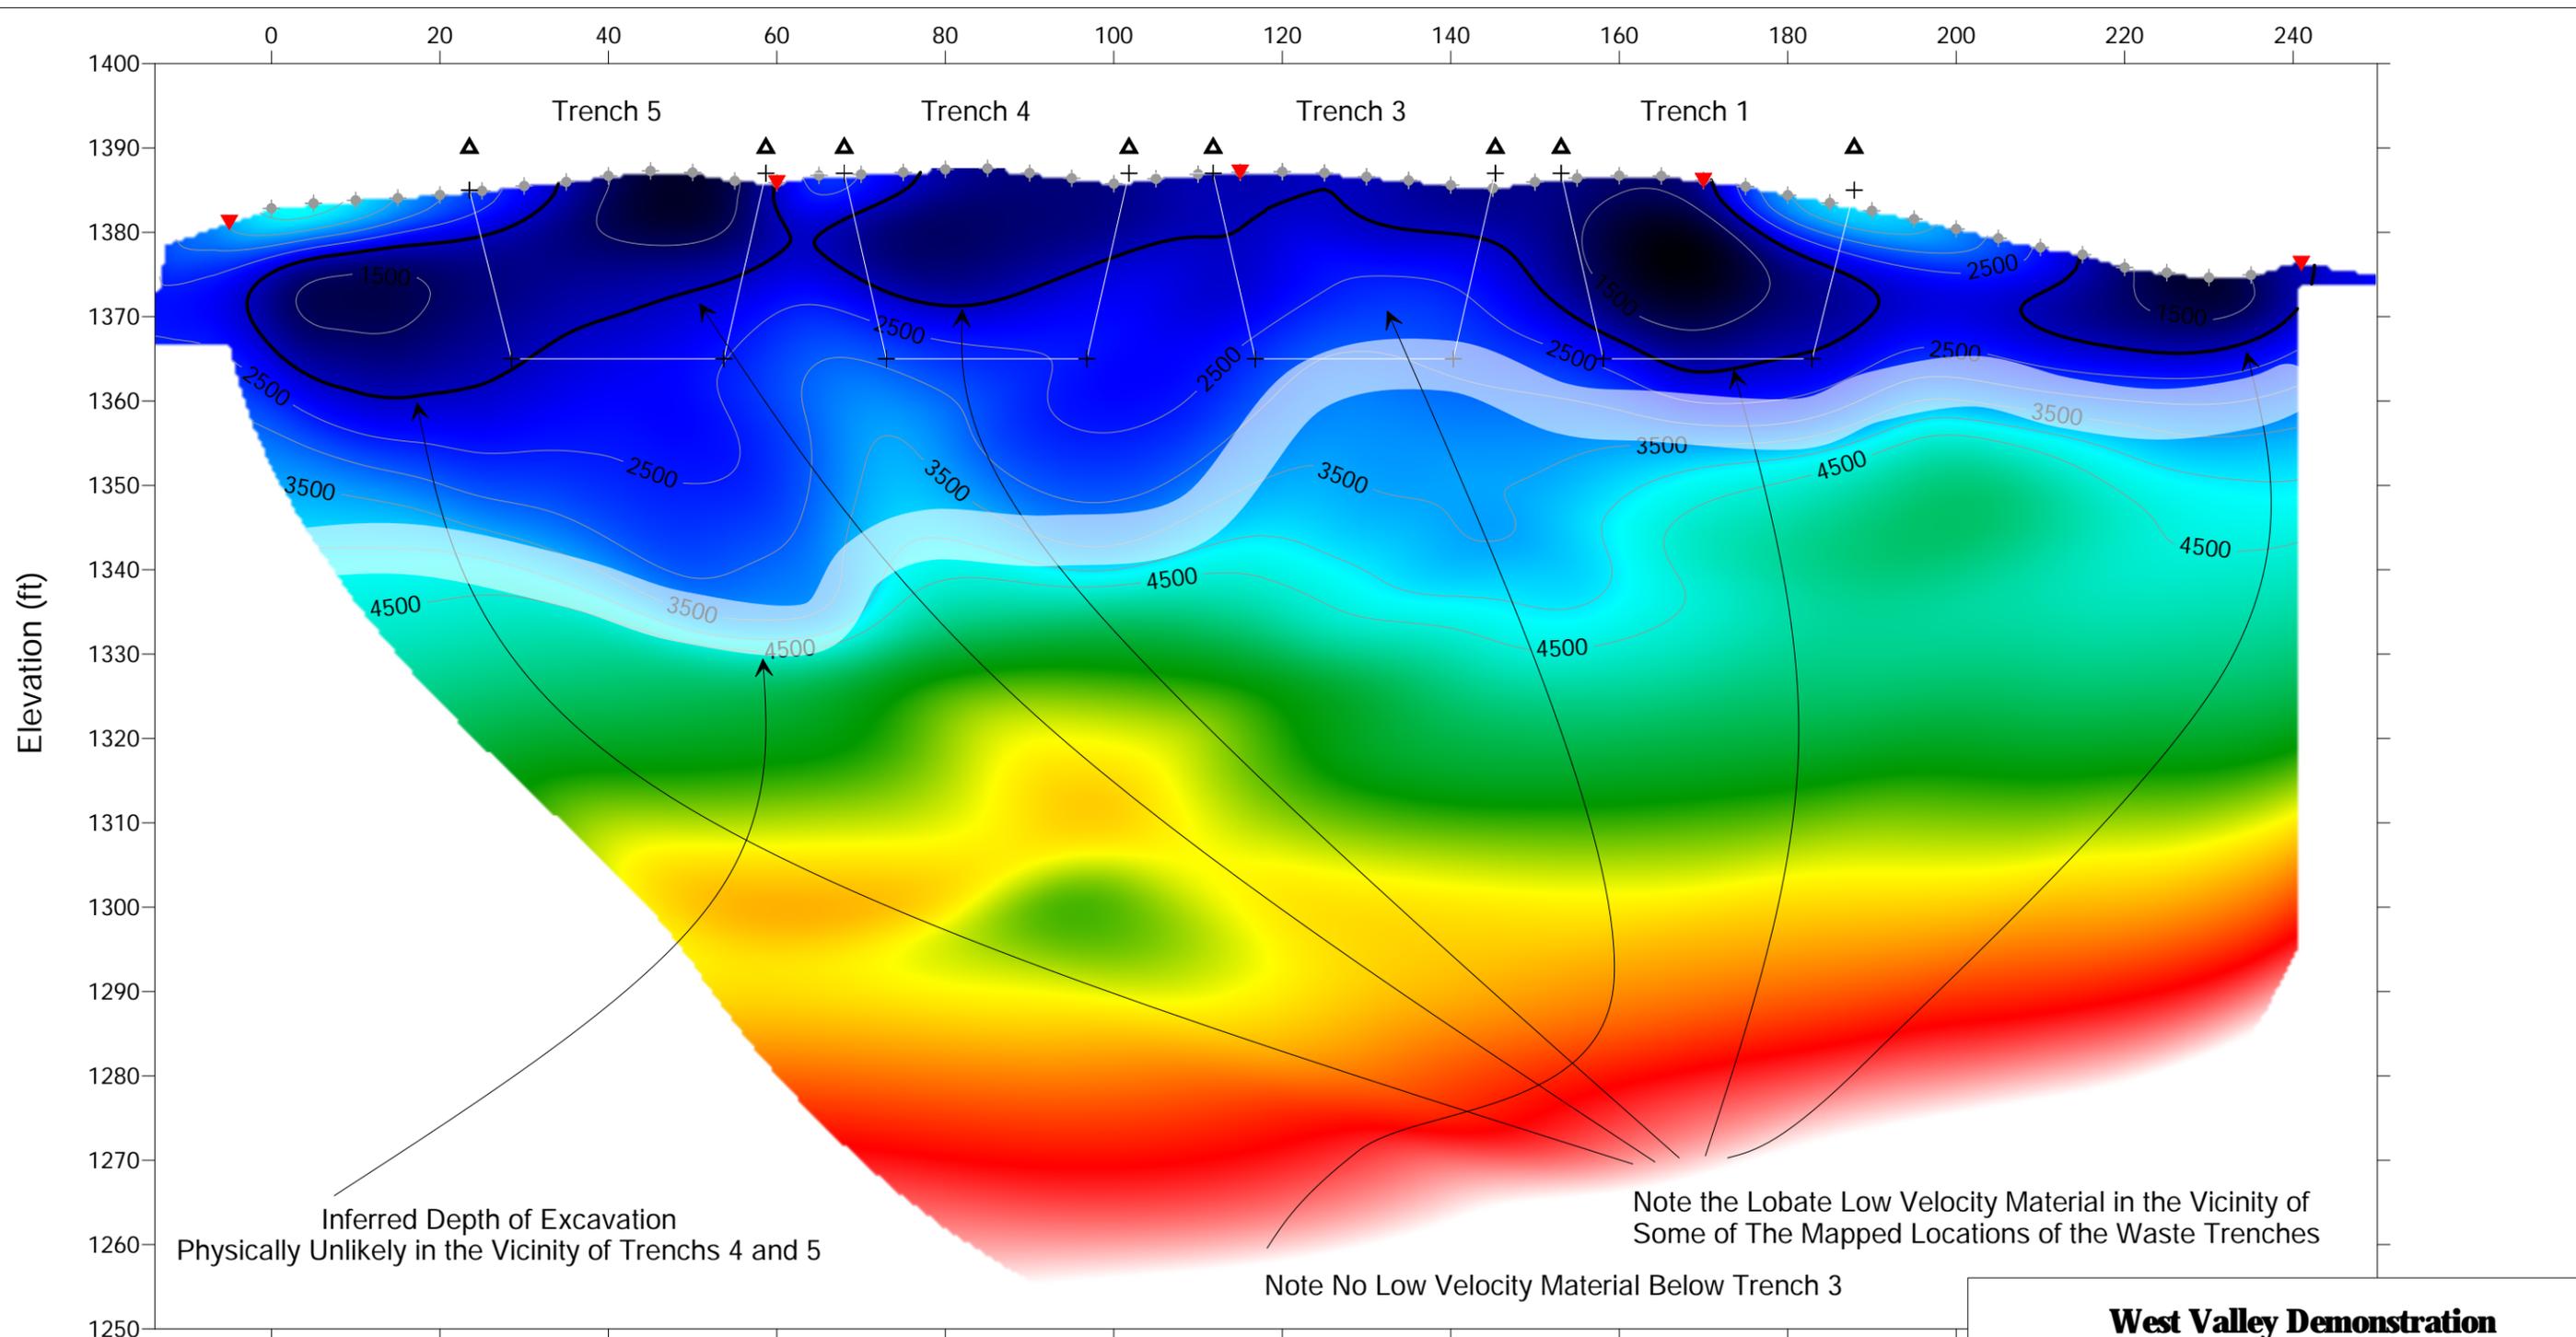
Inferred Depth of Excavation  
Physically Unlikely in the Vicinity of Trenches 4 and 5

Note the Lobate Low Velocity Material in the Vicinity of  
Some of The Mapped Locations of the Waste Trenches
