Report of the West Valley Erosion Working Group

Study 2: Recent Erosion and Deposition Processes

**WEST VALLEY DEMONSTRATION PROJECT AND WESTERN NEW YORK NUCLEAR
SERVICE CENTER**

March 1, 2017

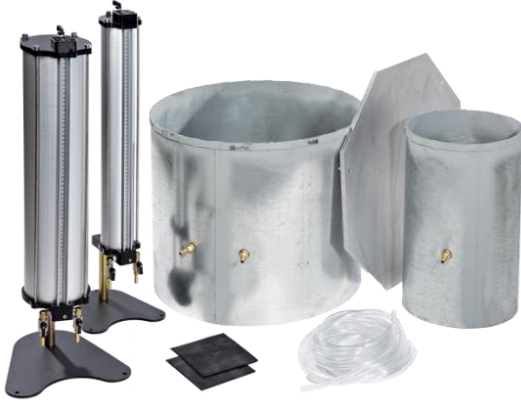
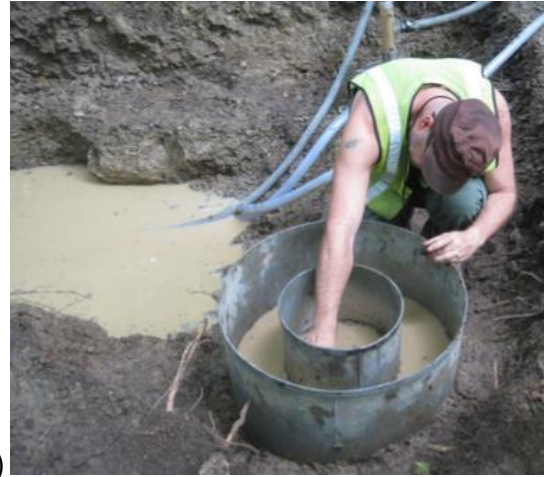
(a)
Figure 2. Double ring infiltrometer used in this study showing (a) its components (image from Humboldt), and (b) its application. The manometers were not used.

To determine the saturated infiltration rate, a standard double ring infiltrometer (ASTM D-3385) consisting of two steel rings was used (Figure 2; Johnson, 1963). Both rings are 508 mm tall (20 in), where the outer ring measures 610 mm (24 in) in diameter and the inner ring measures 305 mm (12 in) in diameter (Figure 2). Maintaining the same water level in both rings creates a constant head that forces infiltration of water in the inner ring downward rather than laterally. The change in vertical water level was measured in the inner ring as a function of time.

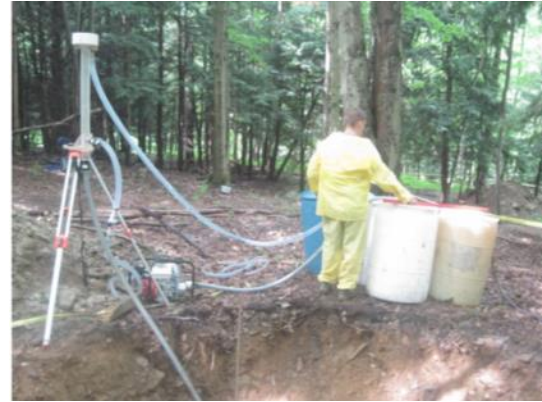
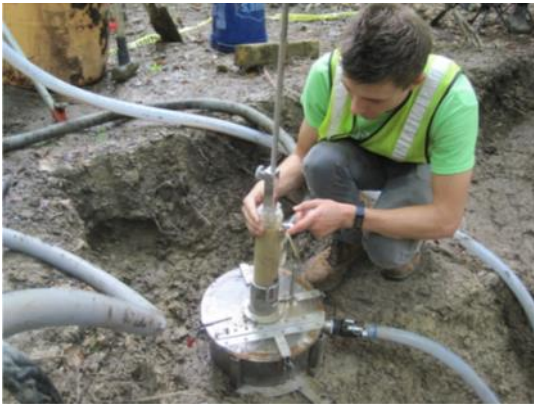
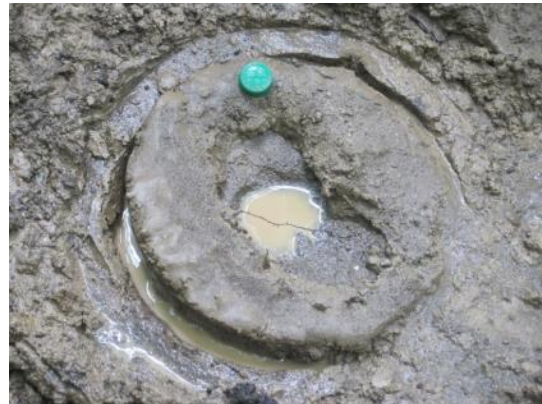
Figure 3. The JET apparatus showing (a) a drawing of the device (Hanson and Cook, 2004), (b) stand-pipe mounted to a tripod, water pump, and local water source (drums), (c) a sealed JET cylinder placed onto a geological material within a dug trench, vertical jet pipe, and point gage, and (d) exposed scour hole (ponded water) once the JET cylinder is removed upon completion of test.

The *in situ* JET apparatus developed by Hanson and Cook (2004) consists of a jet tube, nozzle, point gage, submergence tank, and adjustable head tank (Figure 3). The 0.92 m long jet tube is made of clear acrylic tubing (6.4 mm thick) to allow visual observation of air accumulation in the jet tube. An air relief valve is attached to the top of the jet tube to allow air to escape from the jet tube column during initial filling. The jet tube has an 89-mm diameter orifice plate 12.7 mm thick with a 6.4 mm diameter nozzle in the center of the plate. A 32 mm hose delivers water to the jet tube 0.41 m upstream of the orifice plate. A point gage is attached to the top of the jet tube and aligned with the jet nozzle so that it can pass through the nozzle to the sediment surface to read the depth of the eroded scour hole. The diameter of the point gage is equivalent to the nozzle diameter so that when the point gage rod passes through the nozzle opening, the flow is shut off. A deflector plate is also

attached to the bottom of the jet tube to deflect the jet stream and protect the sediment surface from erosion during initial filling of the tank. The deflector plate is moved out of the way during testing to allow the jet stream to impinge upon the sediment surface (Hanson and Cook, 2004).

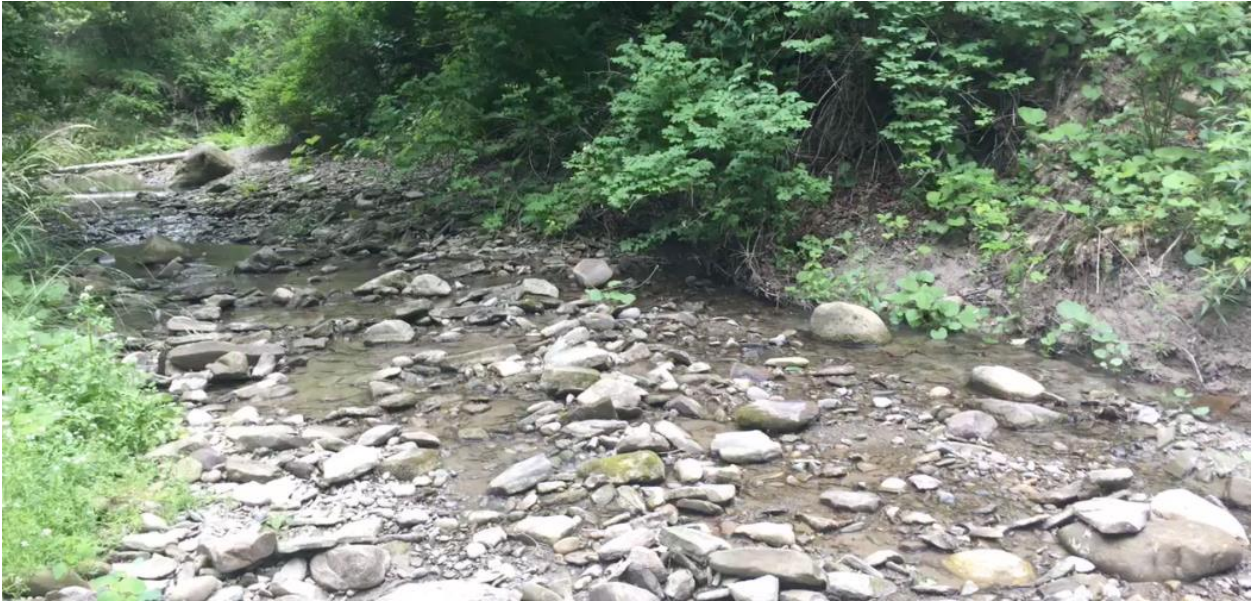
Figure 4. Selected streambed reach for Wolman pebble count method.

After the pebble size was noted, the counter discarded it, took another step, and repeated this process until 100 pebbles or more have been counted. It is important to select pebbles as randomly as possible to minimize any bias in the particles measured, and areas disturbed by human activities should be avoided. Any non-native materials, such as rip-rap, were discounted in the study. From the distribution of pebble sizes, the following grain size percentiles (% finer than) can be obtained: D_{10} , D_{16} , D_{50} , D_{84} , D_{90} , and D_{95} . Here, D_{50} refers to the grain size D in which 50% of the sediment population is finer than this size.

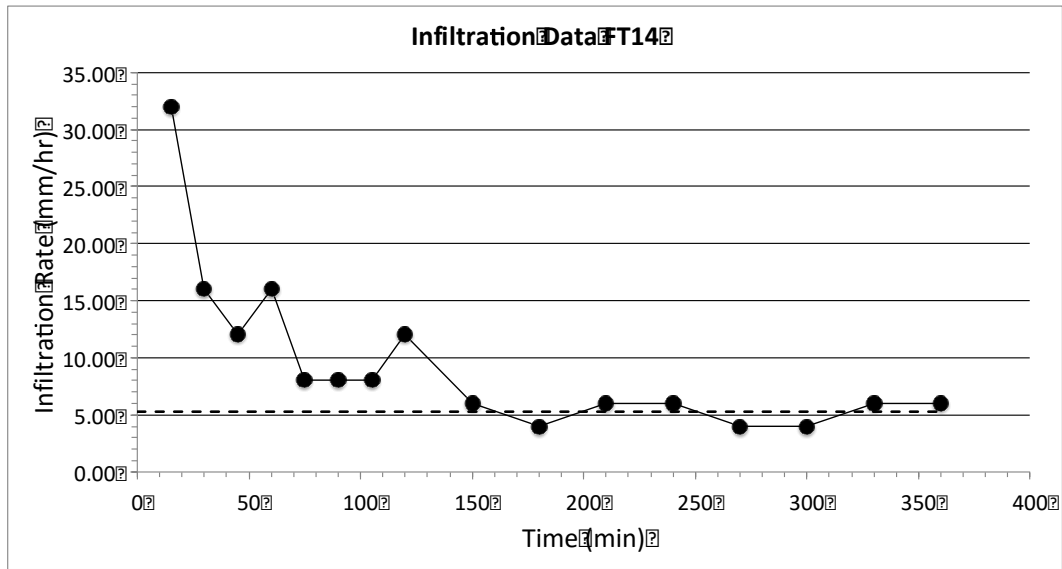
Figure 6. Time variation in information rate for FT-14. The steady-state infiltration rate is shown as a dashed line.

The time variation of infiltration rate for FT-14 is shown in Figure 6. An asymptotic infiltration rate was achieved after approximately 150 min of initiating the test. The steady-state saturation infiltration rate of 5.4±1.0 mm/hr (or 3.4±0.7 m³/yr), using these asymptotic values, is represented by a dashed line. At this same location, several volumetric moisture contents were also taken (Table 1). Based on these values, the volumetric moisture content of the sediment within FT-14 at the time of the infiltration test was 20.0±3.6%.

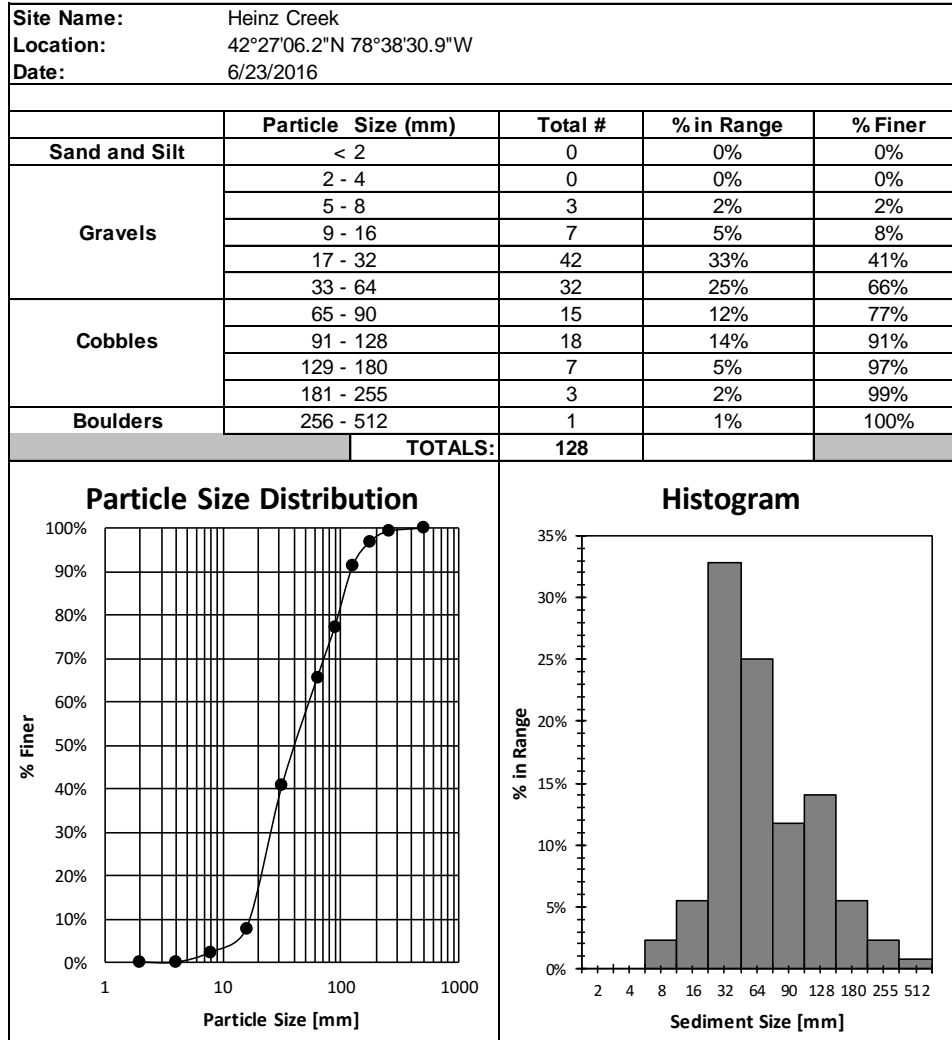
For this location along Heinz Creek, 128 pebbles were measured and sorted into grain size bins. Grain sizes range from 5 to 8 mm (fine gravel) up to greater than 256 but less than 512 mm (boulder). The median grain size of this sediment population D_{50} is 44 mm, or a very coarse gravel.

D ₁₀	17.1	mm
D ₁₆	20.0	mm
D ₅₀	44.0	mm
D ₈₄	108.0	mm
D ₉₀	124.2	mm
D ₉₅	162.2	mm

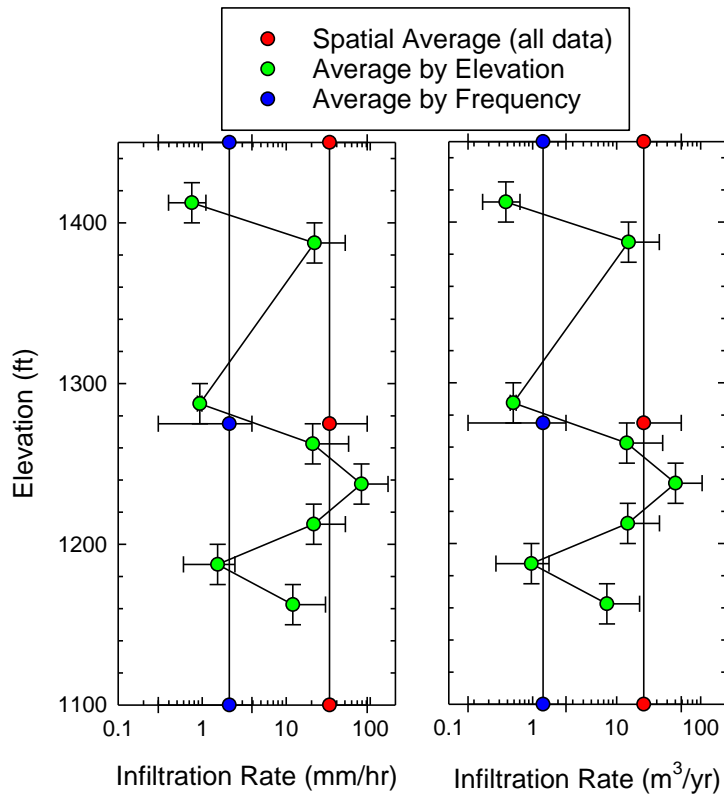
Figure 14. Variation in infiltration rate with elevation using different aggregation methods. Error bars are standard deviation for infiltration rate and applicable elevation range.

For the purpose of modeling landscape evolution, there are several ways these infiltration data can be aggregated. The first approach is simply to derive an average infiltration rate (and standard deviation) using all of the data (i.e., equally weighted). In this case, the average infiltration rate for the entire set of measurements (still excluding HT-32) is 32.8 ± 59.1 mm/hr or 20.98 ± 37.8 m³/yr (Figure 14).

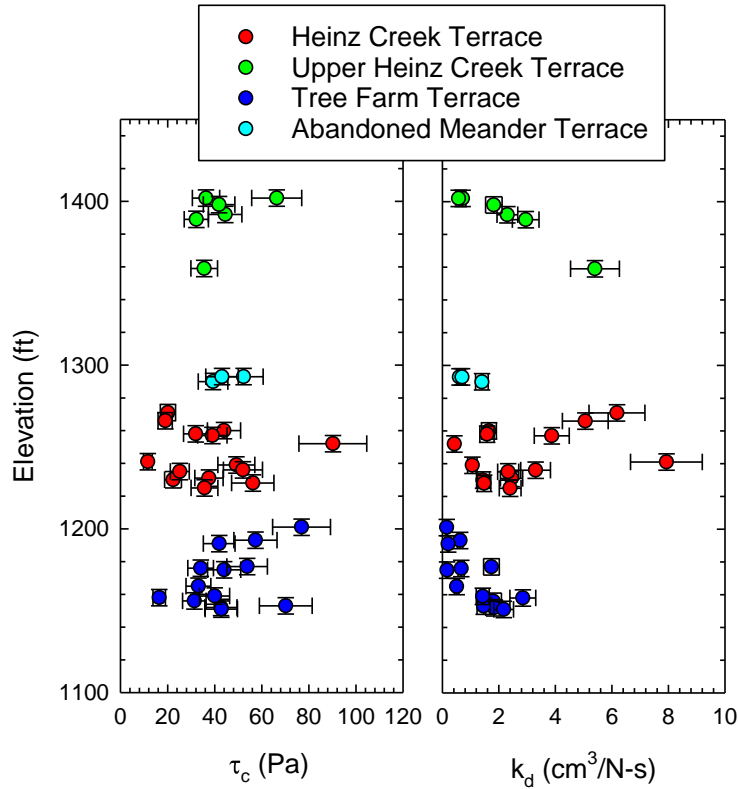
Figure 15. Variation in the critical tractive shear stress τ_c and the erodibility coefficient k_d with elevation for each terrace. Error bars are errors for erodibility indices and 5 ft uncertainty in elevation.

Similar to the infiltration data, the erodibility indices presented in Table 3 were measured for a variety of geological materials with a wide range of landscape positions, geological origins, and spatial representations. The erodibility indices derived using the Scour Depth Solution will be the focus of the current discussion. Figure 15 plots these erodibility data within the landscape, showing that τ_c ranges from 12 to 90 Pa (a variation $8\times$) and k_d ranges from 0.20 to $7.93 \text{ cm}^3/\text{N}\cdot\text{s}$ (a variation of $40\times$). In general, as the value of τ_c increases, the value of k_d decreases (see Hanson and Simon, 2001). Moreover, there does not appear to be a systematic variation in erodibility with elevation.

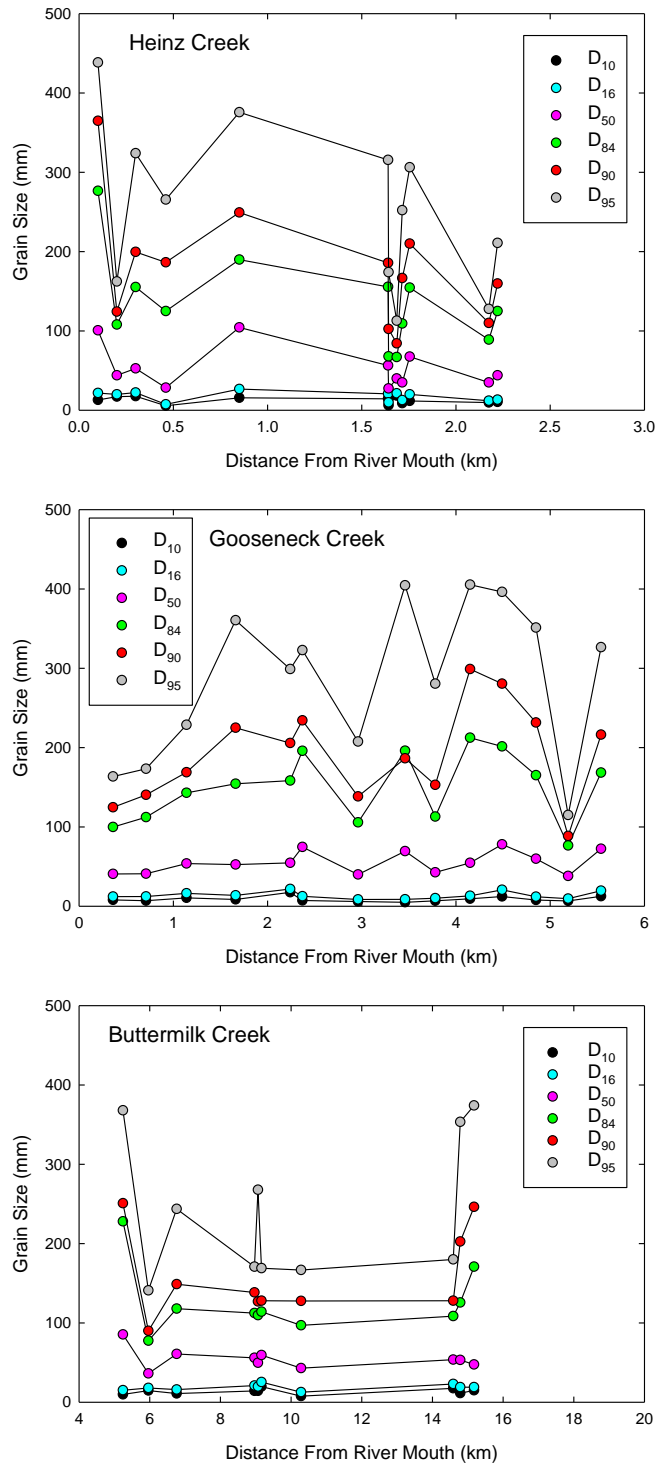
Figure 17. Longitudinal variations in grain size percentiles for stream bed sediments along Heinz Creek, Gooseneck Neck, and Buttermilk Creek.

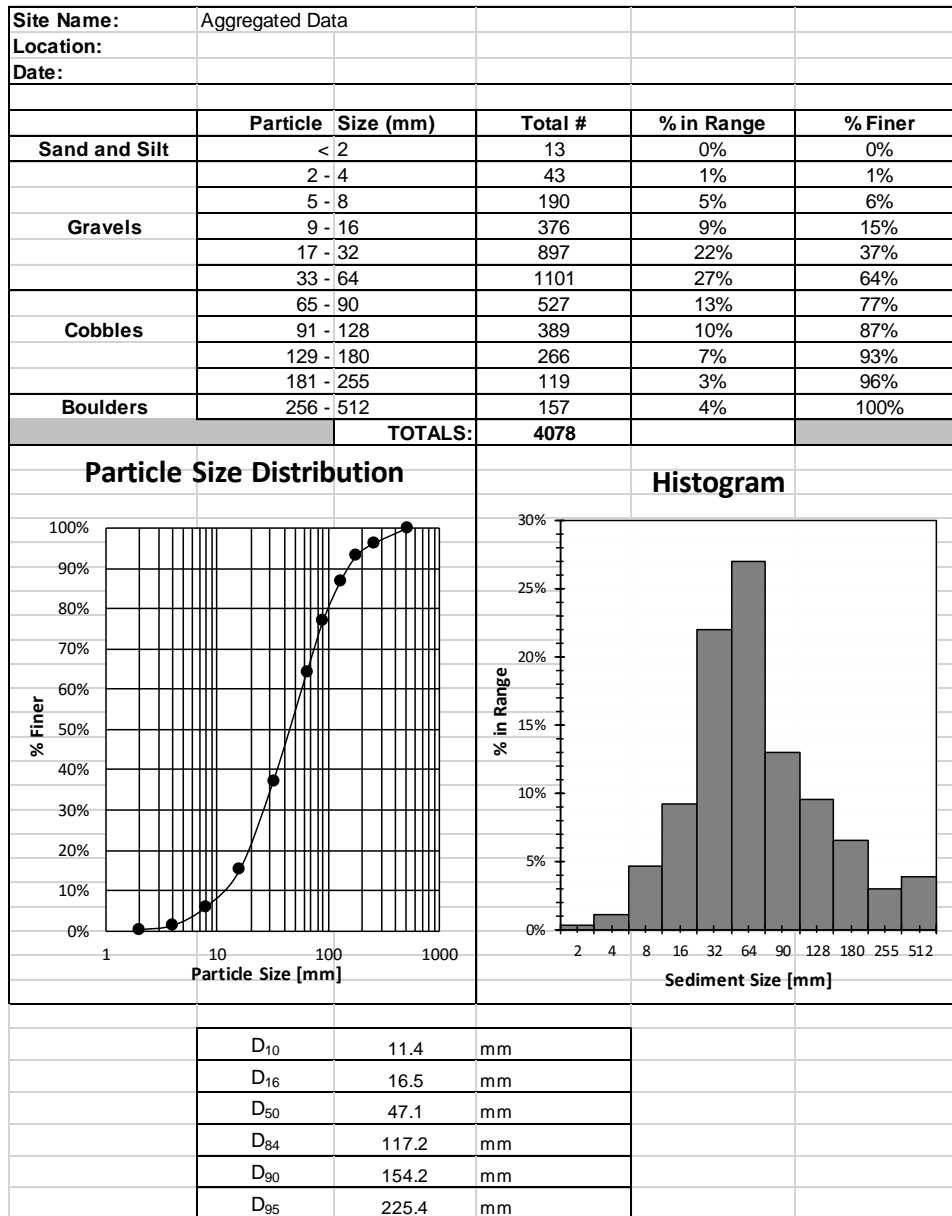
Figure 18. Data sheet, grain size distribution and plots, and derived grain size percentiles determined for the aggregated Wolman pebble count data.

Given that the grain size distributions along selected stream beds do not show statistically significant variations, these data can be aggregated for the purpose of modeling landscape evolution. A Pearson correlation coefficient was derived for each grain size pair (GS-1 vs. GS-2, GS-1 vs. GS-3, etc.), and an average correlation coefficient then was determined for each grain size dataset in comparison to the entire dataset. Those grain size data that had lowest correlation coefficients (less than 0.7) within the population were identified, and these included the following: GS-2, GS-15, GS-29, GS-34, GS-36, GS-39, GS-41, GS-43, GS-44, GS-45, GS-46, GS-47, and GS-48. The remaining data were aggregated, and a representative grain size distribution for the region can be determined (Figure 18). The grain size percentiles for these aggregated data are as follows: $D_{10} = 11$ mm, $D_{16} = 17$ mm, $D_{50} = 47$ mm, $D_{84} = 117$ mm, $D_{90} = 154$ mm, and $D_{95} = 225$ mm. In general, these aggregated grain size percentiles are finer than (or smaller in magnitude) in comparison to the ensemble average values presented above, but still in agreement with those observed by Boothroyd et al. (1979) and used in the FEIS (2010).
